2023年积石山地震重要公共建筑吊顶 震害调查分析

Investigation of seismic damage to ceilings of public buildings during the 2023 Jishishan earthquake

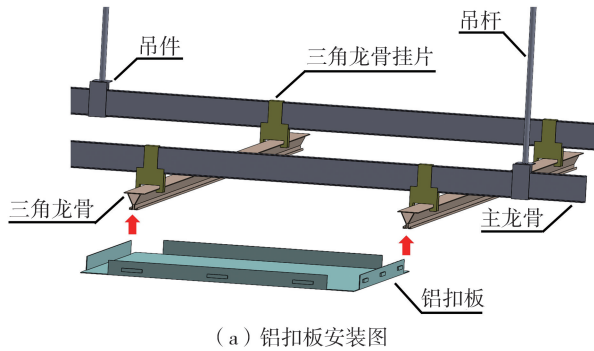
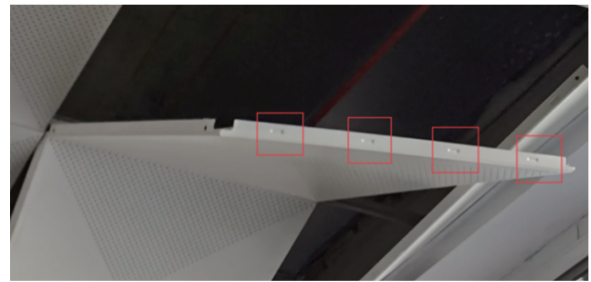
图4 吊顶板安装图

铝扣板吊顶震害与此前常见的矿棉板吊顶震害的共同点是边角破坏比较严重。铝扣板吊顶震害的特殊性是:①由图3和图4可见,三角龙骨同一位置同时卡入2块铝扣板,2块板的卡入边在地震中往往同时脱离三角龙骨,呈对称破坏状态。②不同于矿棉板,铝扣板为金属吊顶板,具有锋利的边角,坠板致伤的可能性较大。幸运的是此次地震发生在深夜,教学楼内没有人员需要疏散,因此并未因坠板造成人员伤亡。③卡入式连接对龙骨网络的抗震性能要求更高,需要始终保持较高的平整度;且卡入连接仅为承担板重而设置,不足以抵抗地震荷载,地震中大量的连接失效足以证明这点。大河家中学吊顶震害和铝扣板吊顶典型震害如图5和图6所示。

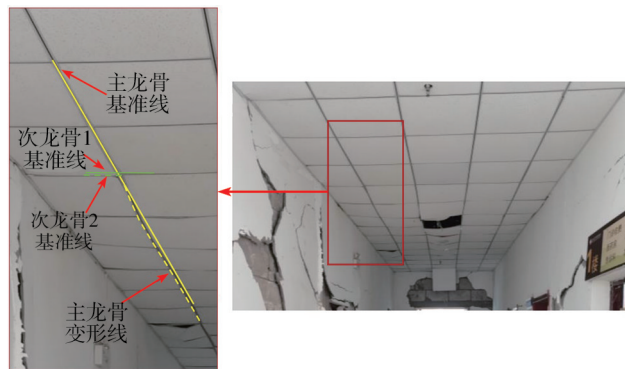
图 7 龙骨网格变形

积石山县中西医结合医院距离震中约 15.8 km,其门诊楼为 4 层框架结构,内部吊顶为矿棉板吊顶。以往的研究或震害调查中,常以坠板率为吊顶损伤的评定依据^[12-14],这的确是方便实用的方法。然而此处震害显示,虽然坠板率较低,仅少量坠板,但主龙骨出现明显扭曲变形,主次龙骨节点也出现多处失效,表明在低坠板率情况下,龙骨网格已经严重变形破坏,如图 7 所示。此类情况在试验与数值分析中曾经出现^[12-14],但在以往震害调查中未见报道。主要原因是在之前震害调查中,多数案例为直挂式吊顶,其竖向主要采用悬吊线与结构连接;而中西医结合医院震害调查发现,采用了间接悬挂式吊顶,根据我国图集 12J502—2《内装修—室内吊顶》^[15],其布置图如图 8 所示,且大量采用吊杆连接,构件布置不同导致了震害的差异。而作为公共建筑常用矿棉板吊顶形式,自 2013 年芦山地震后,其抗震能力薄弱等问题已开始震害调查中凸显,至今 10 a 时间,多位学者对此类吊顶抗震性能展开深入研究^[2,14,16-17],但依据此次地震吊顶震害情况分析,这一现象仍然存在。

2) 间接悬挂式吊顶在坠板率较低情况下,龙骨网格出现大变形,说明在吊顶地震损伤评估中,除坠板率外,应考虑龙骨网格变形等因素。

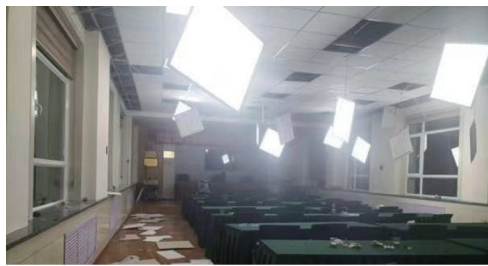
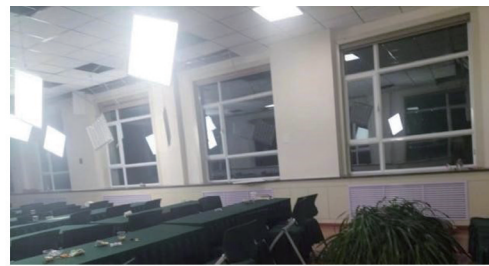
图9 灯具坠落

位于积石山县的中国邮政银行距离震中约 8.7 km,其会议室内部吊顶出现坠落。调查发现,首先边、角部坠板较多,其次几乎所有照明装置均坠落,如图 9 所示。关于照明装置的连接要求,通常依据装置的质量,选用不同连接件与结构相连。如在美国规范中,依据重量不同,可分别采用不同直径的悬吊线或吊杆与结构连接^[18-19]。我国规范和图集中指出^[15],超过一定重量的灯具应直接吊挂在结构顶板或梁上,不得与吊顶系统相连。会议室中吊顶的照明单元为与吊顶板平面形状一致的灯具,属于轻型灯具,安装方式与吊顶板类似,搁置在覆面龙骨翼缘上,除电线外未见其他连接构件,因此在地震中出现大量坠落,又因与电线连接未能落于地面,仅悬吊在吊顶层下方。这说明轻型灯具虽然被允许直接与吊顶系统进行连接,但其抗震性能明显不足。建议依据照明装置质量,分别采用不同悬吊构件与结构进行连接。

3) 建议提高照明灯具与主体结构连接要求,避免地震中大量坠落。
