积石山 6.2 级地震桥梁典型震害特征

摘要: 调查了 306 省道、310 国道以及川亭公路上位于地震烈度 8 度和 7 度区的桥梁。GS.N0028 台站记录到的大河家镇加速度峰值超过 900 cm/s², 远超当地罕遇地震设防标准, 但从调查的结果看, 本次地震中, 8 度区的桥梁震害主要以轻微破坏为主, 包括挡块破坏、主梁侧移和支座滑移, 除了川亭公路上发现一桥梁的桥墩出现剪切裂缝外, 其他桥梁未发现主体结构发生破坏。7 度区的桥梁基本完好, 橡胶支座中橡胶有变形无法恢复以及主梁位移导致挡块间距发生变化, 但都不影响功能。混凝土挡块作为主梁防侧移装置, 震害虽然表明其有效性, 但缺乏快速恢复的特性, 同时设置缓冲橡胶垫的挡块仍然发生了较严重的破坏, 因此, 以后需要进一步加强挡块的缓冲装置和考虑可快速恢复性能的研究。

Typical seismic damage characteristics of bridges in the M_s 6.2 Jishishan earthquake

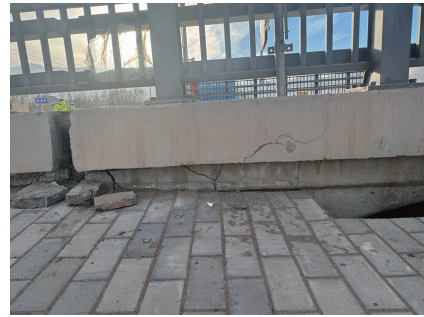
梁两端与桥台的碰撞产生裂缝,如图2所示。主梁南侧伸缩缝处碰撞导致东侧拉开3 cm左右位移,如图3所示。在大河家黄河大桥新桥的北侧有一条沿河走向的地裂缝贯穿桥台,如图4所示。裂缝最大尺寸接近20 cm,导致桥台侧墙和端墙发生严重裂缝,如图5和图6所示。支座的滑移导致连接锚栓折断和倾斜,如图7和图8所示。除此之外,桥梁的附属构件也发生不同程度的破坏,比如排水管拉脱,如图9所示。

图2 南侧伸缩缝处护栏下部混凝土开裂

Fig.2 Concrete cracking at the lower part of the guardrails at the south expansion joint

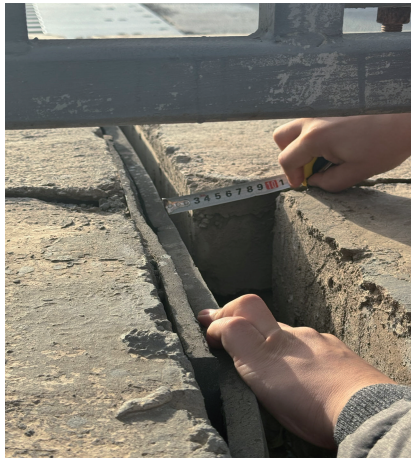
图3 南侧伸缩缝被拉开3 cm 尚未恢复

Fig.3 Pulled apart by 3 cm without restored at the expansion joint on the south

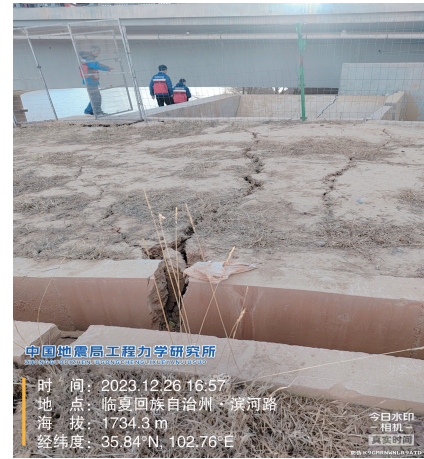
本次地震中未发现河堤处发生液化。由于大河家黄河大桥北侧河堤落差和坡度都比较大,河堤处虽然用石头砌筑加固,但北侧河堤土层仍然出现了一定的滑动,而且拦河堤发生外闪,如图10所示,导致了河堤坡面产生了较大的地面裂缝且通过了北侧桥台,了解到北岸桥台在地震中土层沉陷或滑移,再加上主梁的碰撞导致桥台墙体处发生严重的水平裂缝。

图4 北侧桥台附近地裂缝(闫培雷摄)

Fig.4 Cracks in the ground near the north abutment (Photoed by YAN Peilei)

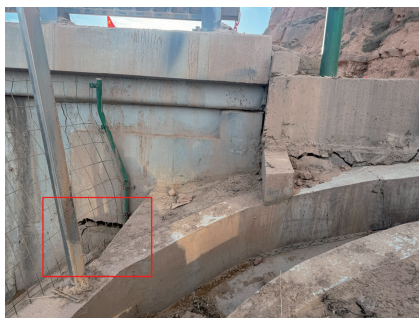
图5 北侧桥台侧墙发生严重水平裂缝

Fig.5 Severe horizontal cracks occurred in the north abutment side wall

3)本次地震中大河家黄河大桥虽然在地震中梁体和桥墩未发生可见破坏,震后仍然保持了功能正常。但北侧桥台墙体发生破坏必须采用适当的工程措施,例如桩基加固等,以提高桥台及其邻近河堤的整体稳定性,确保地震发生时桥梁的安全和功能性。

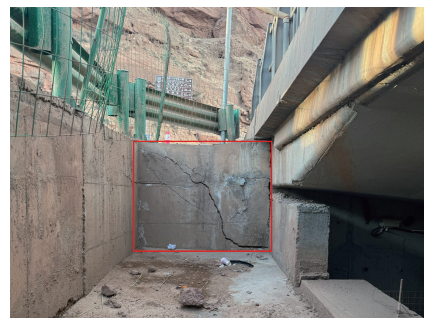
图6 北侧桥台端墙斜裂缝

Fig.6 Diagonal cracks in the north abutment end wall

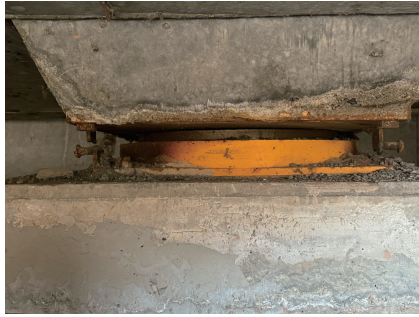
图 7 北侧支座处连接锚栓折断
Fig. 7 Broken of the anchor bolt of the north support

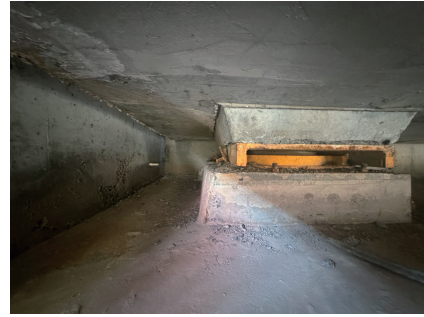
图 8 北侧单向支座连接锚栓被挤压倾斜
Fig. 8 Extruded and tilted of the anchor bolt of the one-way support on the north side

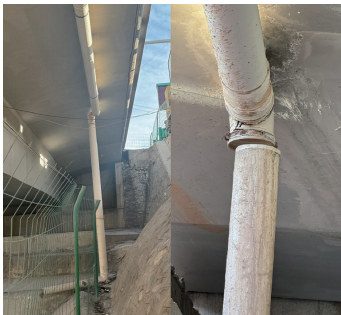
图 9 排水管拉脱
Fig. 9 Pulled of the drainpipes

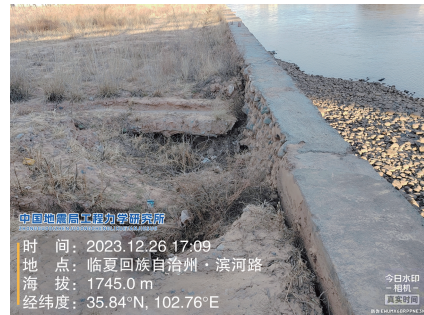
图 10 北侧拦河堤外闪(闫培雷摄)
Fig. 10 Moved outside of the north side of the barrage (Photo by YAN Peilei)

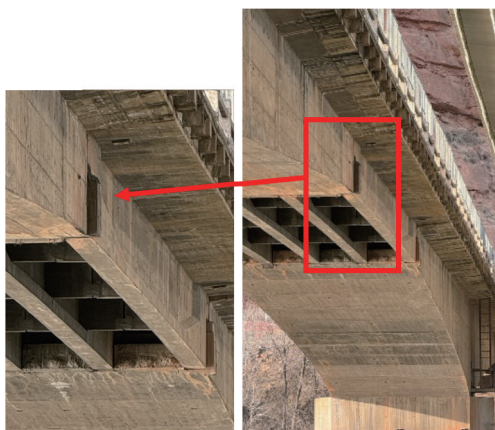
在本次地震中,大河家黄河大桥旧桥位于 8 度区,桥梁主体桥墩、梁未发现明显裂缝,如图 11 所示。主要震害包括跨中“挂梁”挡块发生破坏,如图 12 所示。跨中梁体横向侧移及纵向碰撞如图 13 和图 14 所示。从震害可以看到中部增加的简支梁在地震中易因碰撞发生破坏。

图 12 跨中挂梁挡块发生破坏

Fig. 12 Restrainer damage of the mid-span hanging girder

大河家黄河大桥旧桥中间增加的挂梁^[7],由于无墩柱支撑,其极易在地震中造成碰撞、落梁等破坏,需要增加可靠措施进行加固^[8-11]。

4)大河家黄河大桥旧桥中间的挂梁,由于无墩柱支撑,其极易在地震中造成碰撞、落梁等破坏,需要增加可靠措施进行加固。

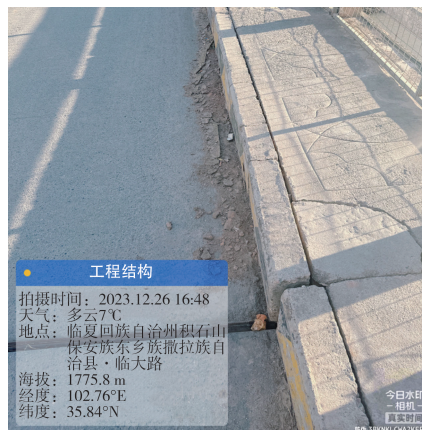
图 13 跨中挂梁横向侧移

Fig. 13 Transverse displacement of the hanging girder

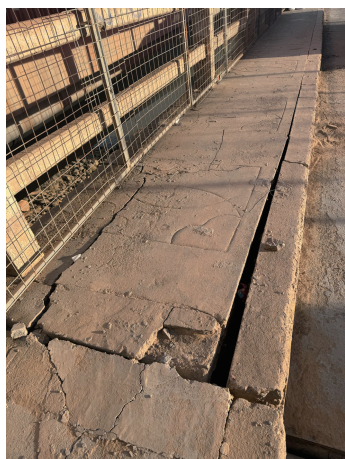
图 14 旧桥北侧梁体碰撞

Fig. 14 Girder collision on the north side of the old bridge

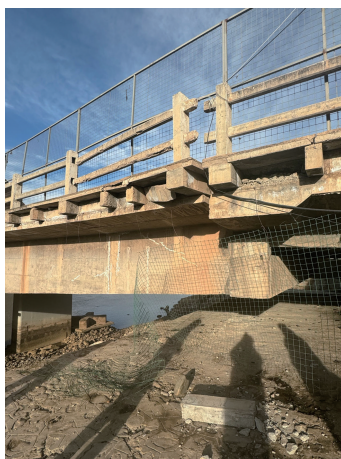
旧桥护栏底部开裂外闪如图 15 和图 16 所示。两端挡块均未设置缓冲装置,南北侧挡块碰撞斜(竖向)开裂如图 17 和图 18 所示。除此之外,南侧有一条沿河流的裂缝(横向)穿过护坡如图 19 所示。

图 15 旧桥南侧护栏底部开裂外闪

Fig. 15 Cracked and moved at the bottom of the guardrail on the south side of the old bridge

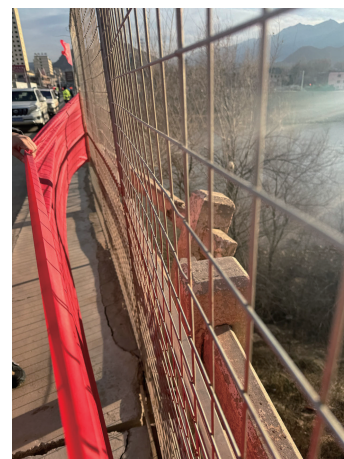
图 16 旧桥北侧护栏外闪

Fig. 16 Moved outside the guardrail on the north side of the old bridge

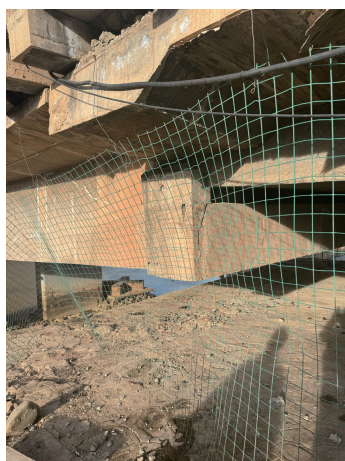
图 17 旧桥南侧挡块斜裂缝

Fig. 17 Oblique crack in the retainer on south side of the old bridge

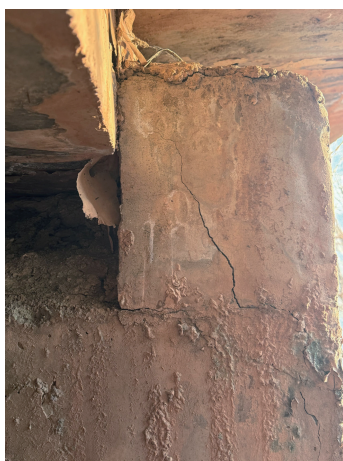
图 18 旧桥北侧挡块斜向下裂缝

Fig. 18 Slanting downward cracks in the north retainer of the the old bridge

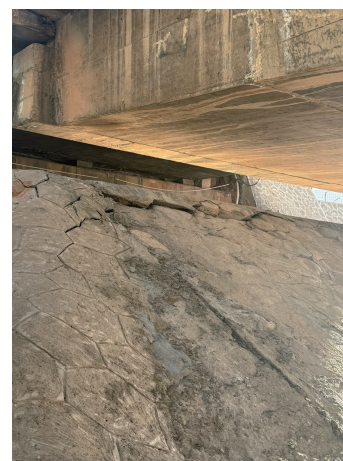
图 19 南侧场地东西向裂缝(桥横向)

Fig. 19 East-west cracks on south site (transverse direction of the bridge)

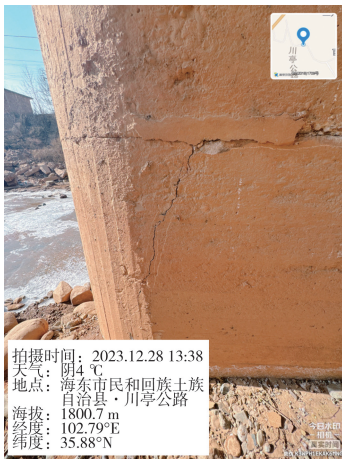
川亭公路通往官亭镇的公路桥梁为一个 3 跨 T 梁简支梁桥如图 20 所示, 桥墩为重力式桥墩, 未发现支座, 中间墩底部有冲刷痕迹。该桥梁位于川亭公路通往官亭镇公路上, 8 度区, 中间跨一桥墩发生严重剪切裂缝, 最长缝长 140 cm 左右, 如图 21 和图 22 所示, 图 21 和 22 中的横向裂缝判断应该是施工缝^[12-14]。该公路桥梁被鉴定为危桥, 整体属于中等破坏^[15]。

图 21 桥墩东侧剪切斜裂缝

Fig. 21 Shear diagonal crack on the east side of the bridge pier

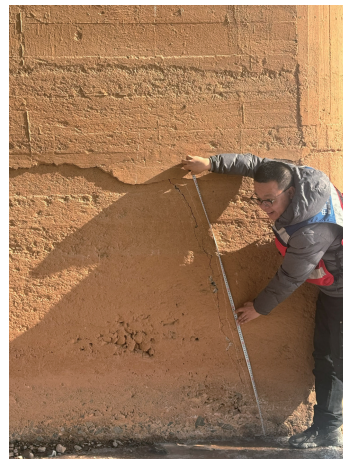
图 22 桥墩西侧 140 cm 长剪切裂缝

Fig. 22 140 cm in length shear crack on the west side of the pier

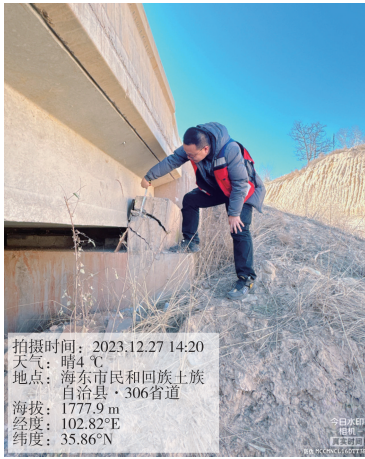
306 省道 K8 段的公路桥梁为双向上下行线的 2 座桥, 均为 3 跨简支梁桥如图 23 所示, 支座为板式橡胶支座。桥梁的桥墩、梁未发现破坏。在桥梁的两端、中间的挡块均由于主梁横向位移导致碰撞而破坏, 其中两端较重, 而中间较轻如图 24 和图 25 所示。两端和中间支座均发生了不同程度的滑移, 最大达到约 10 cm, 如图 26 所示。梁端与桥台发生碰撞及错动如图 27 所示。此桥梁端部挡块设置了缓冲橡胶, 仍然发生了严重的破坏, 中部未设缓存橡胶, 挡块的破坏说明了挡块在抵抗主梁横向移动的有效性^[16-18], 但无法做到快速恢复。设计足够有效且能快速恢复的挡块是一个值得考虑的问题^[19-20], 而且需要对挡块的缓冲装置性能进行进一步的研究。

图 24 公路桥梁端部挡块严重破坏
(设置了缓冲橡胶垫)

Fig. 24 Serious damage of the retainer at the end of the highway bridge (cushion rubber pad installed)

2)本次地震中挡块部分设置了缓冲橡胶,多数未设缓存橡胶,挡块的破坏说明了挡块在抵抗主梁横向移动的有效性;但是这种混凝土的挡块无法快速恢复。从调查现场看到,挡块破坏后基本上要等到几个月甚至更久之后才能得到维修,对于在一些高烈度可能造成强余震风险的桥梁而言,这种挡块设计并非良策,因此,设计出既有效又具有快速恢复的挡块具有非常重要的意义。本次地震中有端部挡块设置了缓冲橡胶,却仍然发生了严重的破坏,因此,以后需要对挡块的缓冲装置性能进行进一步研究。

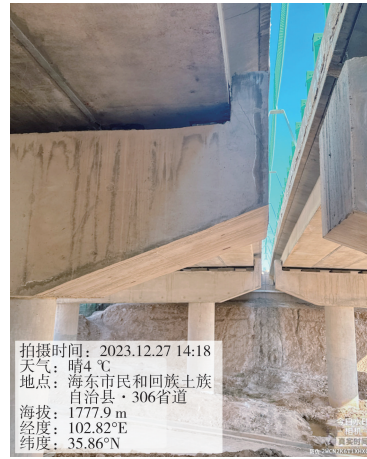
图 25 公路桥梁中部挡块开裂破坏
(未设置缓冲橡胶垫)

Fig. 25 Cracking damage of the middle retainer of highway bridge (without cushion rubber pad)

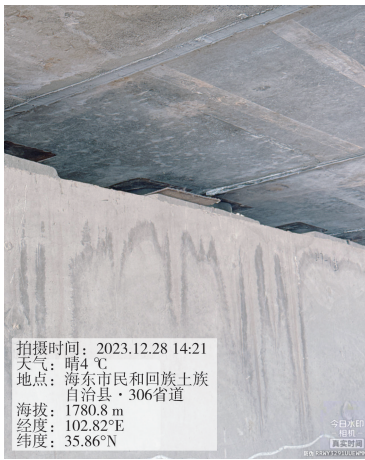
图 26 桥梁中部支座滑移 10 cm 左右

Fig. 26 Slipping about 10 cm of the middle bearing of the bridge

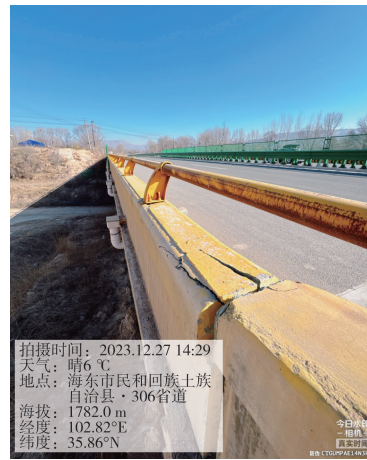
图 27 桥梁端部与桥台错位

Fig. 27 Misalignment between the end of the bridge and the abutment

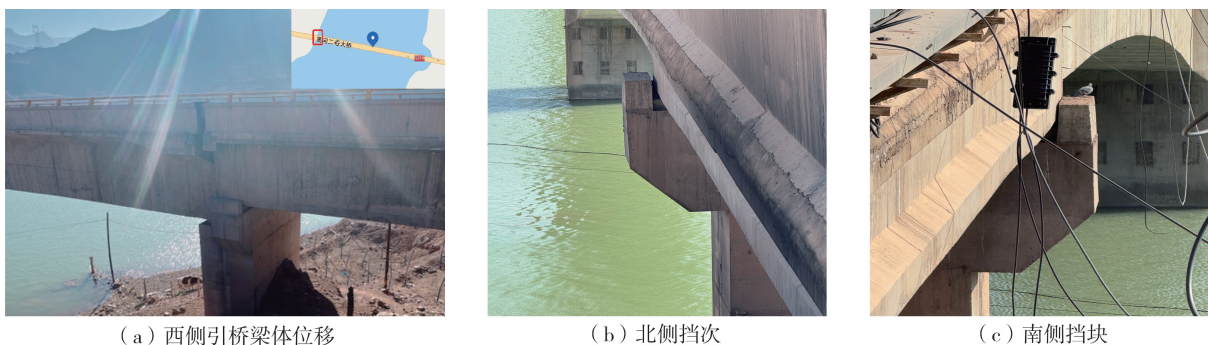
黄河二号大桥主桥为连续刚构桥,引桥为 T 梁简支梁,位于 7 度区。西侧引桥由于地震导致主梁侧移,从而两侧挡块间距产生差异如图 28 所示,主桥与引桥的接缝处也因地震留有碰撞痕迹;310 国道清大线一公路桥梁支座橡胶变形,无法恢复,7 度区,如图 29 所示。两座桥梁均属于完好,震后功能正常。

图 28 黄河二号大桥西侧引桥挡块由于地震导致间距差异

Fig. 28 Difference in the retainer spacing of the western approach span of the No.2 Yellow River Bridge due to the earthquake

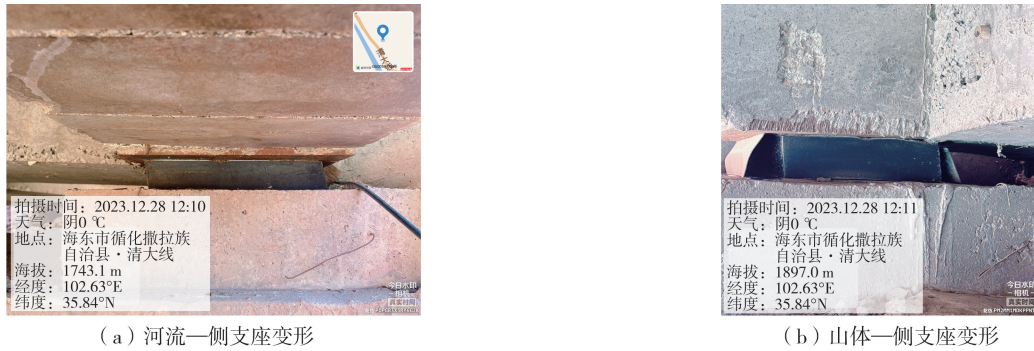
图29 310国道清大线一公路桥梁支座地震后橡胶变形

Fig. 29 Bearing rubber deformation of a highway bridge in 310 National Highway Qingda line
