甘肃积石山地震村镇典型建筑震害及成因分析

摘要: 2023年12月18日甘肃省临夏回族自治州积石山发生6.2级地震, 此次地震造成了大量的村镇建筑破坏和倒塌, 并造成了多人伤亡, 是典型的“小震大灾”。文中总结了积石山地震中震区村镇建筑典型震害特点和规律, 并结合建筑的结构类型、建造年代和是否具有抗震构造措施进行了典型案例分析, 总结此次地震震损较为严重的原因: 部分自建房屋为砖柱和土坯墙, 二者缺乏有效连接, 自身抗震能力差, 这点从同一院落具有圈梁构造柱的房屋基本完好而不具备抗震构造措施的房子破坏严重可以说明; 部分房屋不同层存在开间变化导致竖向传力不连续; 结构存在大量平面布置不规则的情况; 结构局部不完整或存在薄弱部位; 农村自建房屋, 按照工匠习惯建设, 未考虑地震作用下的受力要求, 需要建立质量监管体制机制。

Cause analysis and typical damage of town and village buildings of the Jishishan earthquake in Gansu Province

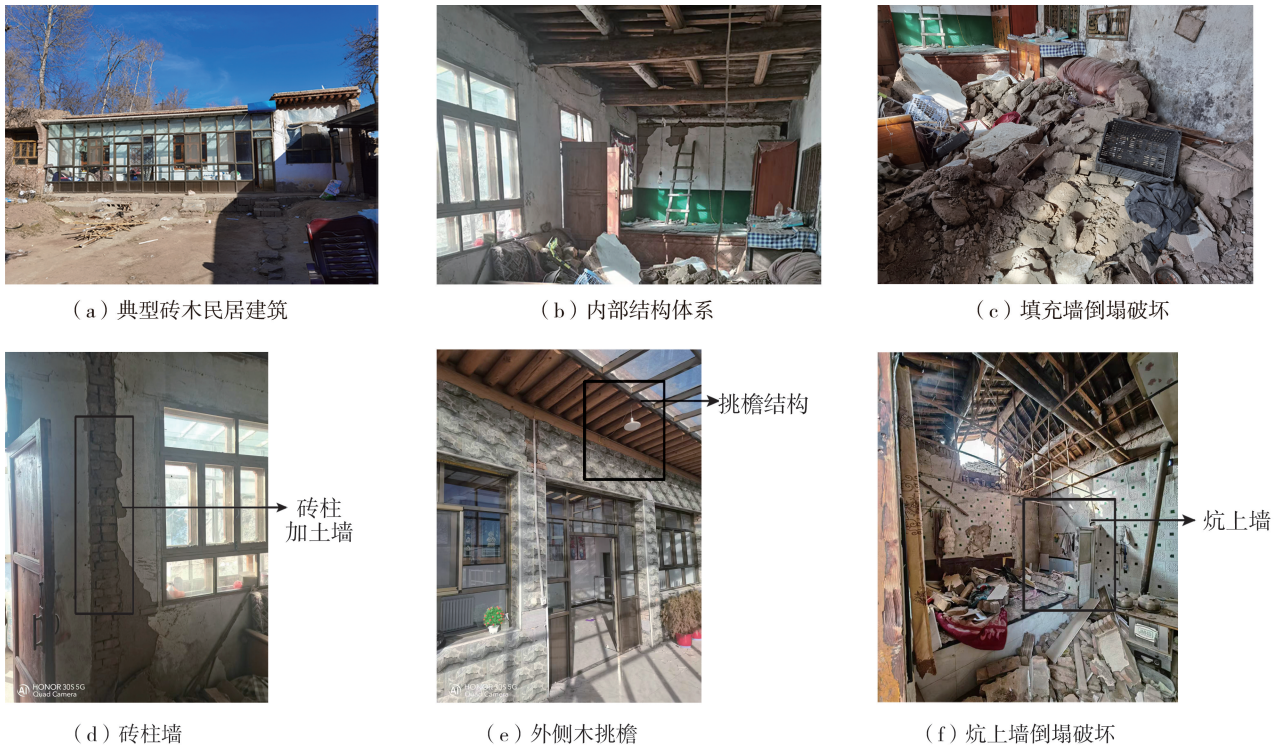
图1 砖木结构的典型破坏

此次地震村镇建筑尤其是农村存在着大量的砖木结构,部分建成年代较早的砖木结构填充墙为土坯墙,如图1(a)所示。这类房屋主要以砖柱或者砖墙为竖向承重构件,如图1(b)所示。屋内隔墙根据建成年代不同,分为砖墙和土坯墙,如图1(c)所示。大部分建成年代久的房屋以土坯墙为主,屋面通常为泥土屋面上覆瓦,并且部分房屋做了苦背处理,屋面竖向荷载通过木梁传递到砖柱或者砖墙,如图1(d)所示。由于建成年代早,建筑质量差,材料的黏结性差,砖柱与木结构梁之间缺乏有效的连接,屋内砖墙或土坯墙与地面和屋面的连接强度不足,砖柱和砖墙的砌筑质量较差,砖与砖之间缺乏搓牙砌筑或者是有效的咬接;砖柱与砖柱之间的土坯墙连接性更加薄弱,同时砖与砖之间的砌筑材料有水泥砂浆、砂浆和黄土,这就造成了砖与砖之间在承受水平向荷载时不具备足够的承载力。与此同时,震区民居建筑大部分具有前廊结构,通常为外挑木屋檐加竖向支撑网格木架,造成结构在水平向上存在刚度和外形的不对称性,加之地震作用具有方向性,这也加剧了此类建筑的破坏,如图1(e)所示。

由于当地回族的习俗,回族男子在清真寺做礼拜可以在清真寺附属的公共浴室淋浴洗澡,而女性则必须在家里进行沐浴,加之当地经济水平较差,临夏回族自治州冬季平均温度是 $-9.0\sim+4.0\text{ }^{\circ}\text{C}$,因此当地习俗是在居室内的火炕上搭建一堵临时墙,如图1(f)所示。这堵墙与房屋外侧墙构成的空间作为妇女的沐浴场所,在本次调研的大部分情况下,这种隔断性质的临时炕上墙通常为半高状态,不与上部屋顶连接,几乎浮放于炕上,与一侧墙体均不连接或者仅抵接,由于炕上砖墙具有很高的质量,加之不可靠的连接,在地震作用下

很容易发生倾覆,导致位于炕上墙内侧的人员被压埋或者砸伤,这也是此次积石山地震造成人员伤亡的主要因素之一,因这种不合理结构造成的人员伤亡数量占此次地震近 1/3 的比例。

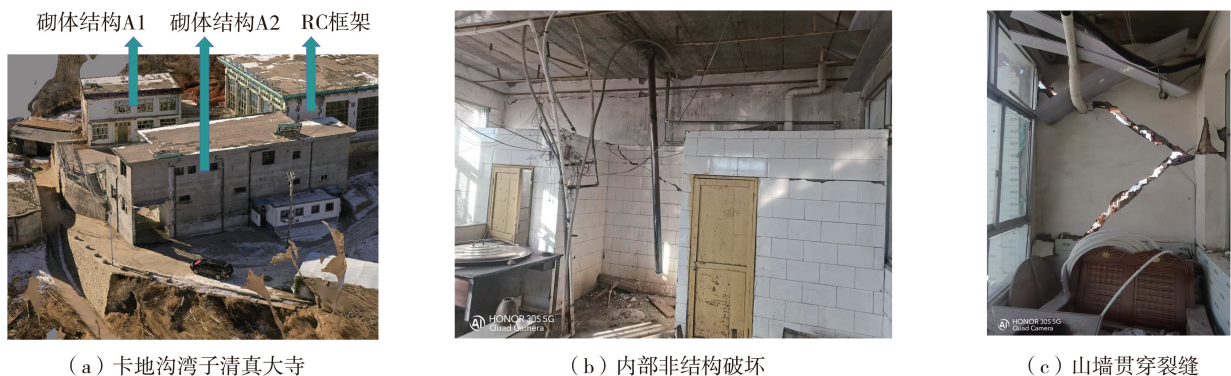
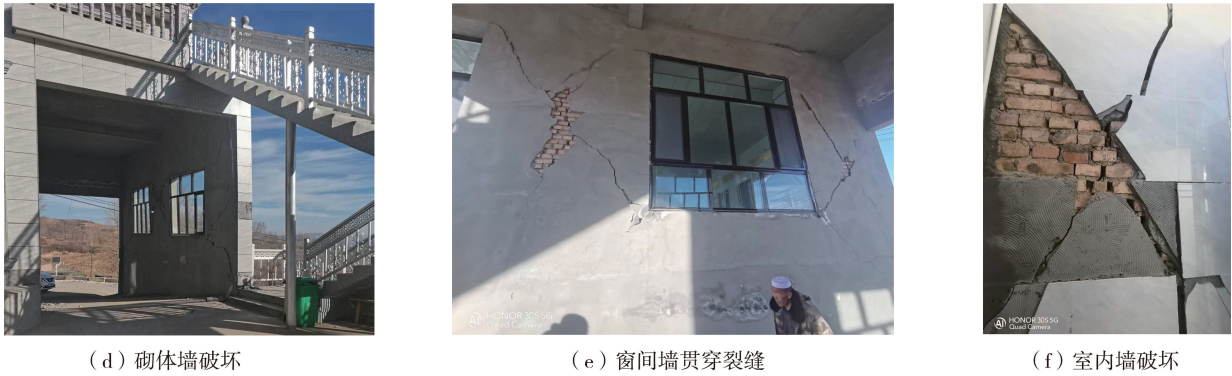
图 2 砖混结构的典型破坏

地震中大量砖混结构发生破坏,其中部分砖混结构发生倒塌,选取几栋典型砖混结构如图 2(a) 所示。图 2 所示建筑为卡地沟湾子清真大寺,位于青海省海东市民和回族土族自治县官亭镇的民族村,属于烈度异常区。图 2(a) 中砌体结构 A1 为 2 层砌体结构,结构主要破坏包括山墙贯穿裂缝、砖柱剪切破坏、室内包括管线在内的非结构构件的破坏、室内墙的开裂;图 2(b) 中砌体结构主要破坏包括门洞两侧墙体的贯穿裂缝,构造柱底端的剪切破坏、室内墙及饰面的破坏等。2 栋砌体结构破坏的主要原因:①结构所处地形为山坡局部突出部分,结构的地基下部土层深度不一致,结构紧邻边坡外缘,因此存在着地震动放大作用,导致紧邻边坡一侧地震作用更大;②结构平面和立面的不规则性,导致结构刚度不均匀,存在着薄弱环节,在地震作用下更容易发生破坏,例如图 2(d) 由于通行需要而设置的通道,导致结构的平面和立面刚度都不均匀,同时外侧局部走廊也导致这种连接更加脆弱。

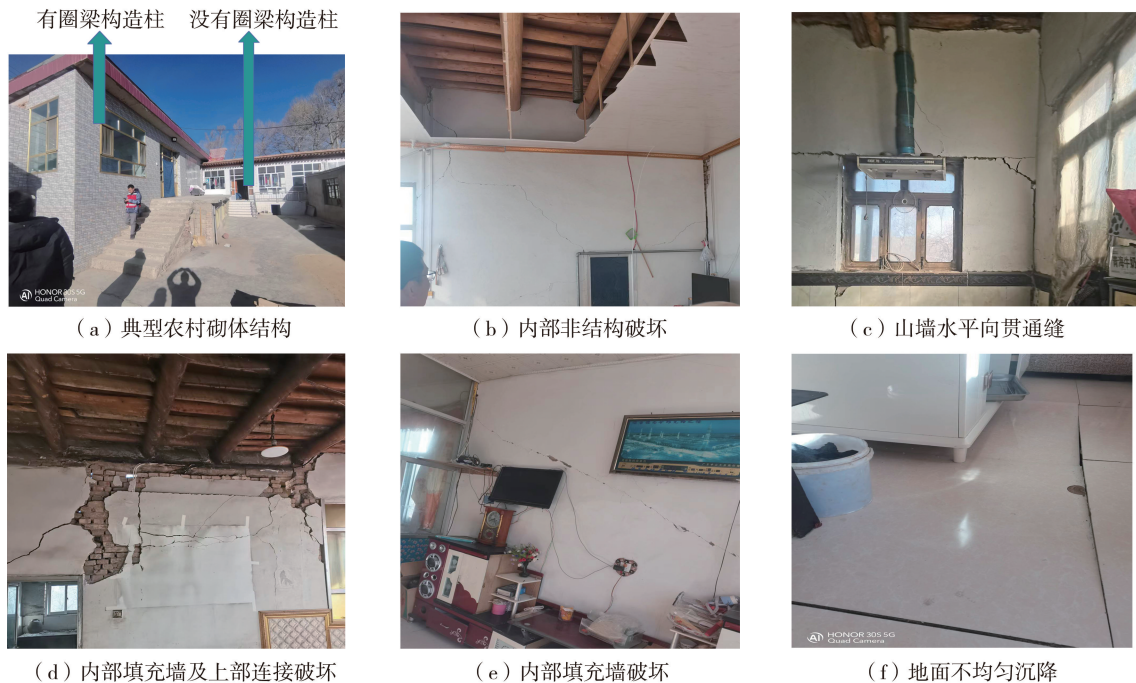
图 3 农村砌体结构的典型破坏

图 3(a)中 2 栋农居同样位于烈度异常区,一栋具有圈梁构造柱,建于 2020 年,另一栋没有圈梁构造柱,房龄在 10 a 以上,没有采取抗震构造措施的结构在此次地震中发生了破坏,包括吊顶板的脱落、山墙的水平向贯通裂缝、室内地面的不均匀沉降和室内填充墙的破坏等。而有圈梁构造柱的这栋建筑没有发生破坏,2 栋建筑形成了明显的对比,也说明了合理的抗震构造措施对于提高结构的抗震安全具有显著的提升作用,此次地震中,在不同的村镇和不同的院落均存在这种对比性比较明显的农居建筑,从一个侧面彰显出建造具有抗震构造措施的民居建筑的重要性,可以极大地提高内部人员的安全性并显著减小经济损失。

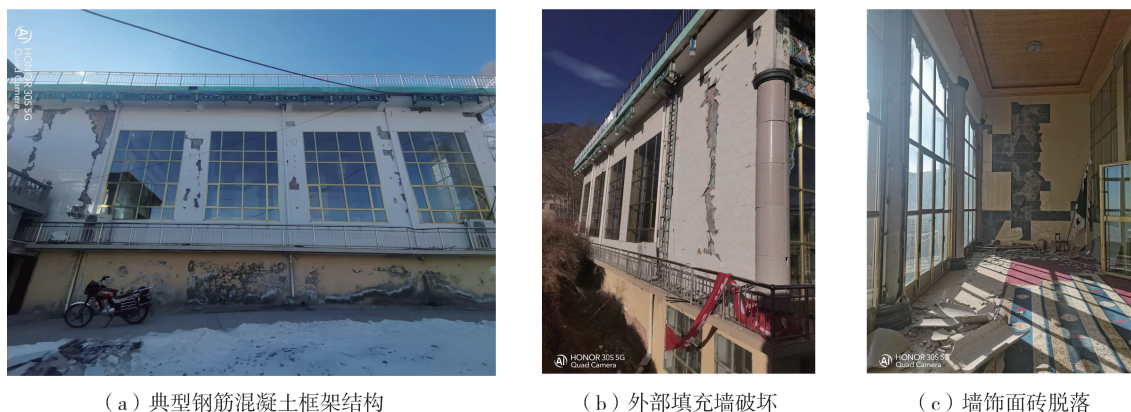
图4 钢筋混凝土框架结构的典型破坏

地震烈度异常区的民族村还有数栋钢筋混凝土框架结构,其中的代表为卡地沟湾子清真大寺的主体结构,钢筋混凝土框架结构如图 2(a)和图 4 所示。这栋建筑在地震作用下主体结构未发生明显破坏,结构的破坏主要是外部填充墙破坏。图 4(a)的外侧窗间墙裂缝为竖向通缝,这主要是由于窗间墙之间为钢筋混凝土柱,柱两侧与窗之间采用砖砌筑,由于两侧砖墙宽度较小,加之与柱之间没有采用钢筋进行有效拉结,且砌筑砂浆黏结力不足,导致产生了如图所示的竖向贯通缝。框架柱与框架梁之间的填充墙也在梁下侧产生了水平向管贯通缝及竖向缝,同时还伴随着墙外立面砖、柱子装饰砖、屋顶装饰物等非结构构件因连接失效发生部分坠落,如图 4(b)所示。

(b) 外部填充墙破坏

(c) 墙饰面砖脱落

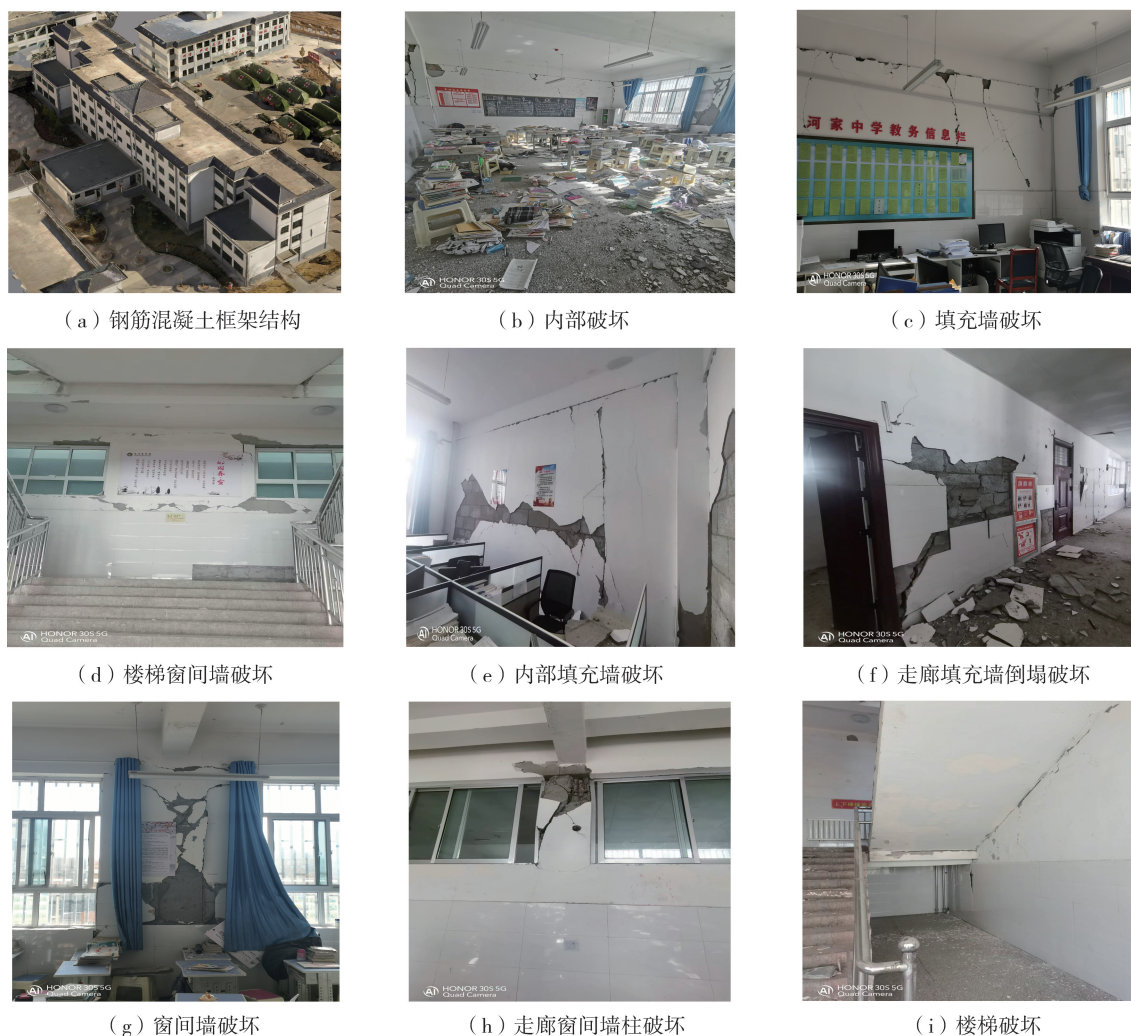
图5 学校类钢筋混凝土框架结构的典型破坏

除上述烈度异常区建筑的破坏,本文还选择了此次地震震中区大河家镇的部分钢筋混凝土框架结构。图5为积石山县大河家中学,该中学教学楼为钢筋混凝土框架结构,尽管在此次地震中结构的主体梁柱未发生破坏,但该建筑几乎所有的内部填充墙、窗间墙、内部走廊两侧墙体和楼梯间墙体均发生了不同程度的破坏,并且大部分破坏都无法修复,需要拆除重建。填充墙作为非结构构件,在破坏性地震作用下几乎很难保持完整,此次地震的震中区,绝大多数建筑内部填充墙及承重砖墙都发生了不同程度的破坏,这种破坏在震后修复也非常困难。

(b) 内部破坏

(c) 填充墙破坏

(d) 楼梯窗间墙破坏

(e) 内部填充墙破坏

(f) 走廊填充墙倒塌破坏

(g) 窗间墙破坏

(h) 走廊窗间墙柱破坏

(i) 楼梯破坏

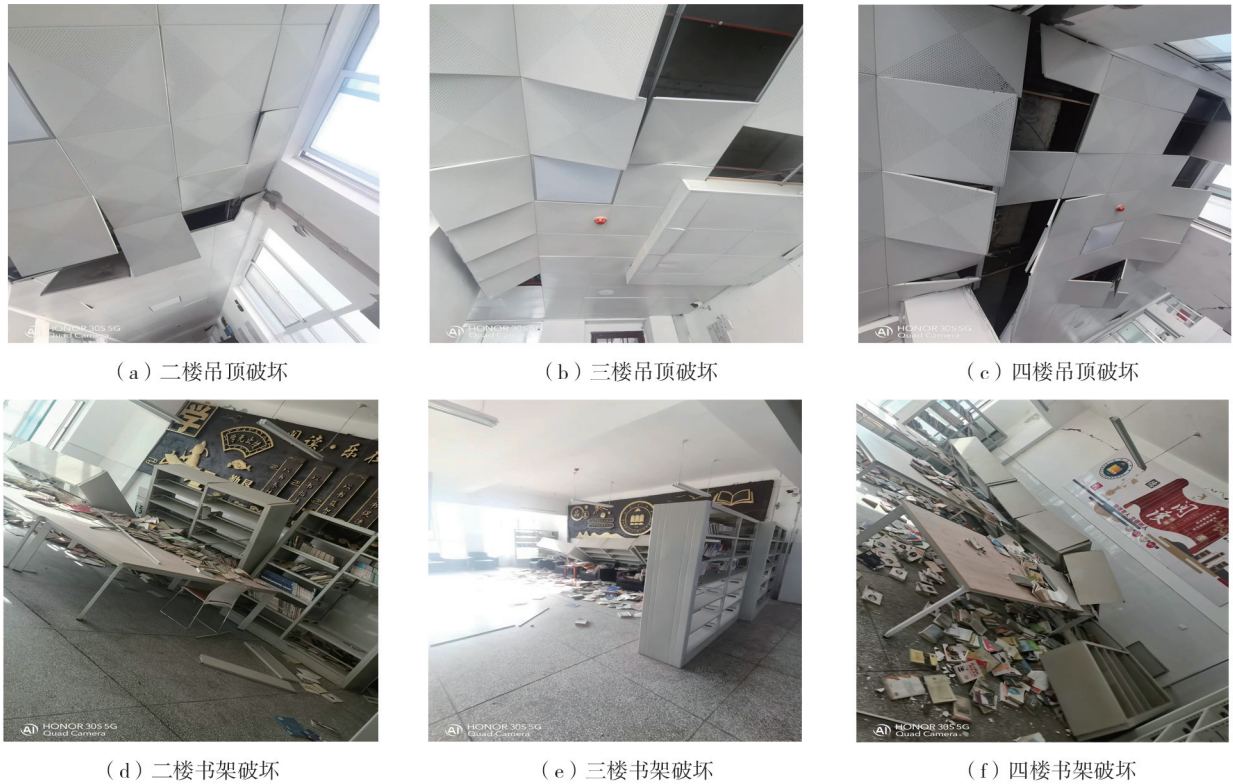
图 6 典型非结构破坏

积石山县大河家中学教学楼除大量墙体发生破坏外,另外几种典型的学校类建筑的非结构构件也发生了较严重破坏,图 6(a)~(c)是二楼至四楼的吊顶发生破坏的照片。由图可知,随着楼层增高,地震动加速度被逐层放大,吊顶的破坏越加严重。这种规律也适用于图 6(d)~(f)所示的靠墙放置的书架,同时从图 6(e)也可以看出尽管靠墙书架发生倒塌,但是与墙垂直放置的书架并未倒塌,这也说明地震具有方向性效应,在地震作用的主要方向上破坏更加严重,因此吊顶和书架这类非结构构件与主体结构应该进行可靠的连接,保证在地震作用下连接不发生破坏。

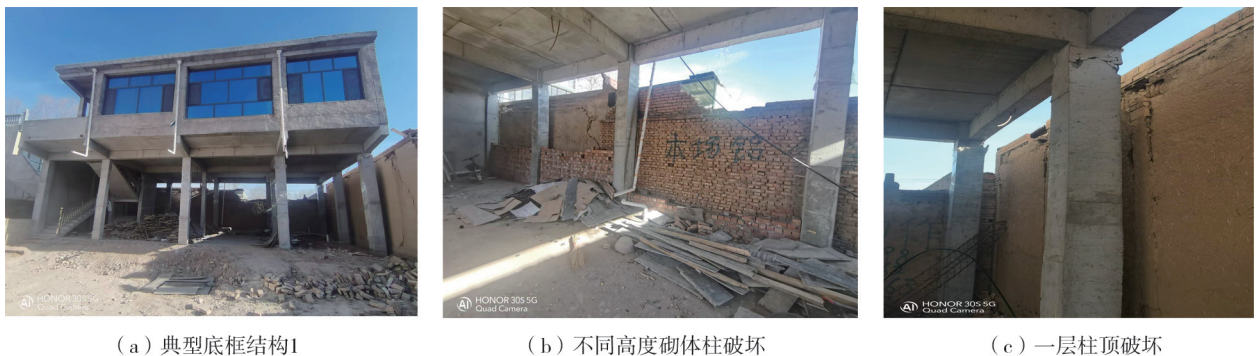
图 7 底框结构典型破坏模式 1

在我国历次历史地震事件中,底框结构的震损都十分严重,典型的底框结构如图 7 所示。一楼为框架结构,承担主要的商业功能,二楼及以上存在部分承重墙和填充墙,因此一楼是所有楼层中的薄弱环节,通常在 一层柱底或者柱顶发生柱的剪切破坏,这种结构类型也基本难以实现强柱弱梁的设计理念。

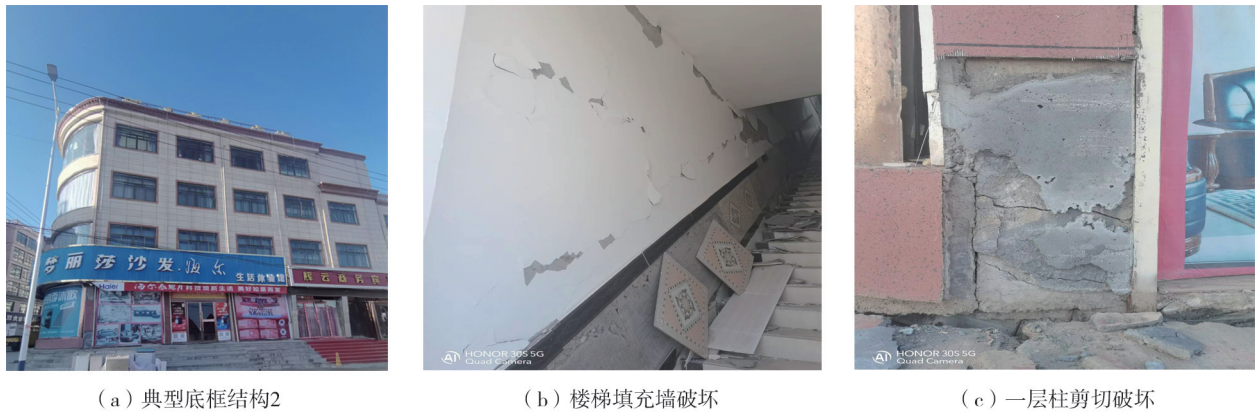
图8 底框结构典型破坏模式2

图8所示建筑为地下1层地上4层的底框结构,结构的内部墙体、楼梯间两侧墙体等均发生了破坏,而由于一楼仅通过竖向柱承担竖向和水平向地震作用,加之柱子的截面较小,导致一层柱顶均发生了剪切破坏,整体结构发生了扭转,这使得这类结构震后修复更加困难。

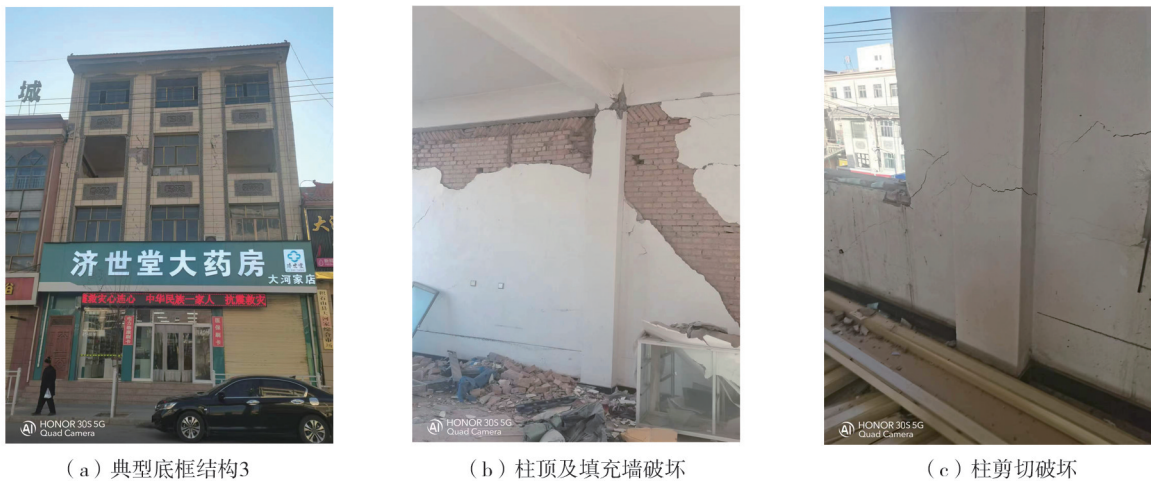
图9 底框结构典型破坏模式3

图9所示为一栋4层的底框结构,结构一层至二层破坏较轻微,这主要是由于一层和二层柱截面较大,具有足够的安全储备,而三层至四层的柱为变截面柱,柱子截面显著减小,导致该结构的三楼和四楼发生严重破坏,如图9(b)、(c)所示;三层和四层建筑的柱顶、填充墙、门窗和窗间墙等均发生了严重破坏。而破坏的主要原因就是变截面柱造成了结构竖向刚度的突变,导致三层和四层不具备足够的安全储备。

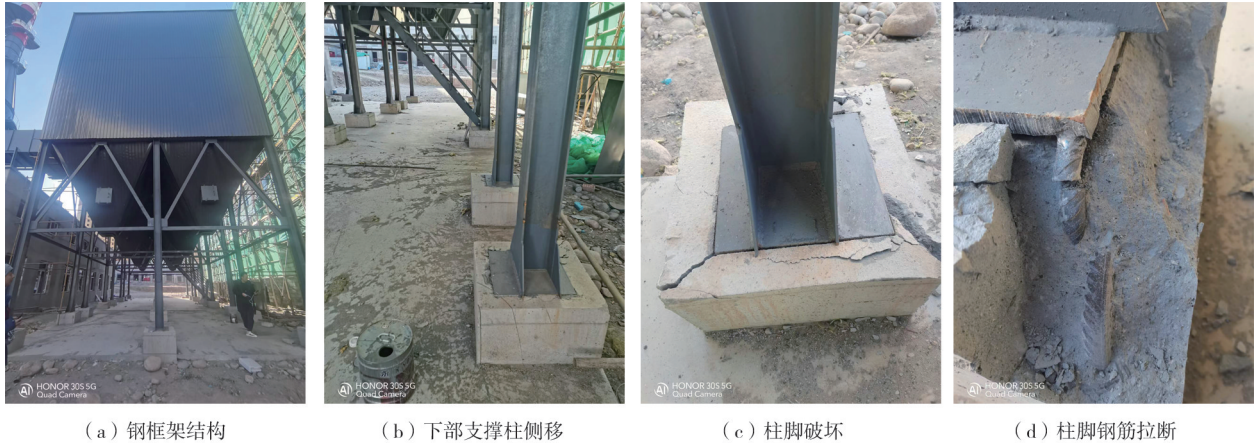
图10 钢结构典型破坏

某供热公司链条炉中作为灰斗的钢结构如图10所示,由图可知,这是一个典型的“头重脚轻”的钢结构,上部荷载通过下部型钢柱承担,此次地震作用下,结构下部的支承柱发生了明显的侧移,如图10(a)所示;同时柱与基础的混凝土桩顶连接部位发生连接破坏,如图10(b)、(c)所示。由于混凝土桩的截面和强度不足导致桩头被拉裂,同时也有部分连接板下部锚筋被拉断,如图10(d)所示。由图10的典型破坏可知,结构的支座和连接部位破坏是地震作用下破坏的主要模式之一,这也说明了在设计过程中应该重视支座和连接部位的强度和延性,做到强节点和强锚固。
