DOI:10.12404/j.issn.1671-1815.2309636

泸定地震典型底商多层建筑震害与机理分析

Earthquake Damage and Mechanism Analysis on Multi-story Buildings in the Luding Earthquake

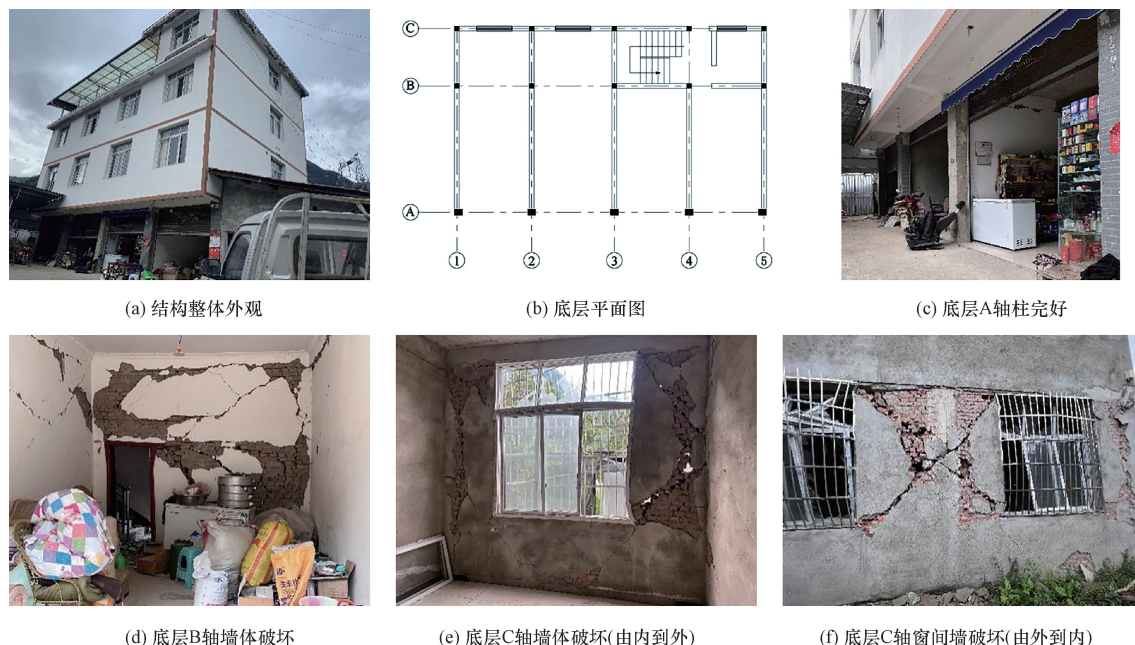
图1 富有小卖部震害

富有小卖部位于得妥镇南头村1组,是一栋三层(局部四层)底商建筑,结构外观如图1(a)所示。震后结构从正面看基本完好,然而内部和背面破坏十分严重。底层平面图[图1(b)]显示,该结构横向有5道轴线,均设置了不开洞的砌体墙;纵向有三道轴线,A轴是空旷的框架柱,B轴由构造柱以及③-⑤跨间的砌体墙组成,C轴是开设窗洞的含构造柱的砌体承重墙。横向总刚度明显大于纵向总刚度,横向各道墙的破坏轻微。纵向是震害分析的重点,纵向A轴线框架柱仅柱端出现少许混凝土剥落[图1(c)];B轴各构造柱基本完好,但③-⑤轴间的两道砌体墙发生严重剪切破坏[图1(d)];C轴破坏更严重,窗间墙被X形裂缝分成4块,左右两块外移,挤扁的窗框,上下两块高度相对缩短,显示楼板已经下坠,结构接近倒塌[图1(e)、图1(f)]。

该建筑破坏形式如图1所示。从平面布置图可知,横向总刚度明显大于纵向刚度,约束了结构横向变形,地震作用下,各层现浇刚性楼板以纵向平动为主,这在振动台实验中也得到了验证^[20]。如图5(a)、图5(b)所示,缩尺比为1:4的三层框架模

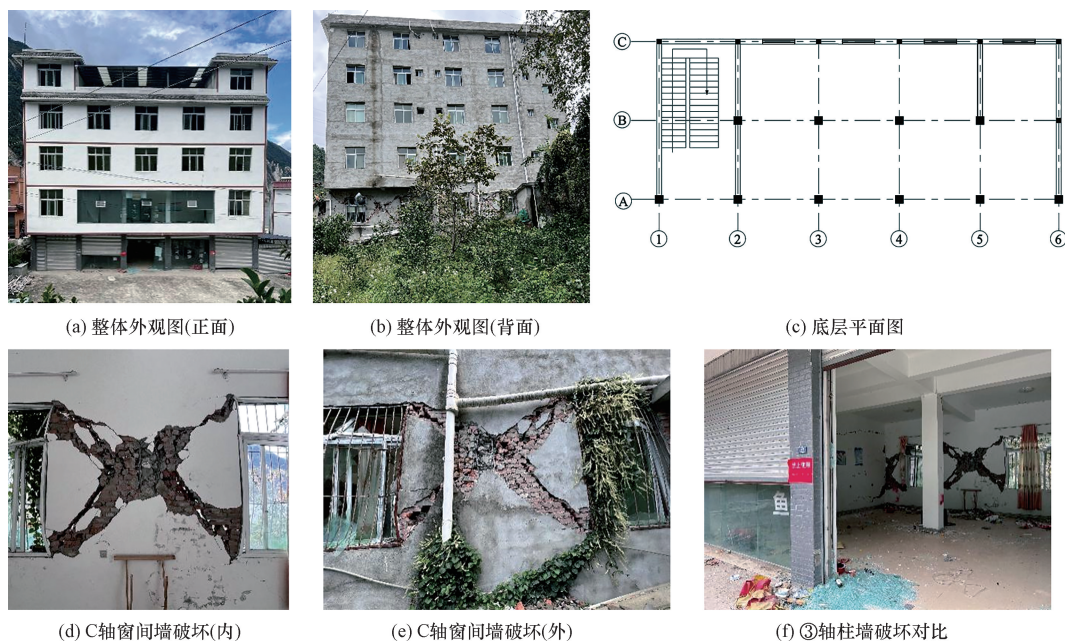
图2 得妥南头1组7号建筑震害

得妥镇南头村1组7号建筑与富有小卖部仅相隔百米,结构形式基本一致,是一栋五层框架-砌体混杂式的底商建筑,其正面和背面如图2(a)、图2(b)所示。底层为饭店,空间开阔,图2(c)所示的底层平面图显示纵向A、B两道轴线采用混凝土框

架柱,C轴线为带构造柱的砌体墙。横向①、②、⑥三道轴线为不开洞的承重墙。

结构破坏集中在底层。图2(d)、图2(e)显示,C轴的窗间墙出现X形贯穿裂缝,墙面像四块三角形块体构成的拼图,左右两块“离心”而去并挤扁了窗框。上边的倒锥体随楼板一道下沉(量测显示下沉8 cm)。斜裂缝交叉处构造柱混凝土剥落、钢筋屈曲呈S形也是楼板下沉的证据。墙面破损的状态应该经历两个阶段:墙段分担的剪力首先造成贯通X形裂缝;左右两个块体在地震惯性力作用下单向往外移动,裂缝宽度迅速扩展,上部块体下沉。值得注意的是,图2(f)所显示的③轴两柱一墙破坏状态的强烈对比。尽管窗间墙崩解为块体、高度降低,可是两根柱的上下端并无明显损伤,既没有混凝土剥落,也没有屈曲的钢筋出露。这说明在地震过程中,柱上下端所经历的层间位移并不大。两柱一墙破坏形态的强烈反差说明,楼板相对地面的位移很有限,否则柱端会有明显的破坏。柱与墙的上端都嵌固于现浇的楼板内,运动是同步的。楼板受不开洞的横墙约束在横向几乎不变形,只能沿着纵向平动,震害显示楼板的纵向平动主要由C轴的墙来阻止,墙因为分担了绝大部分地震剪力才导致自身粉碎性破坏。这种位移小、破坏重的现象与文献[5]中所描述的“变形饱和”非常一致。

硬脆构件达到极限承载力,相对于弱延构件的极限变形而言,而此时侧向变形仍然很小,但是硬脆构件已无法承担任何侧移的增加,定义硬脆构件达到了“变形饱和”状态。硬脆构件的承重失效将会触发结构倒塌,而此时弱延构件的延性作用并未得到发挥。这样就容易理解图2(f)显示的现象,窗间墙粉碎时同一轴线上的柱还几乎完好。窗间墙粉碎后无法承重,导致楼板下沉,同时各道横墙也失去“扶壁”作用,如果此时地震没有停止,横墙将发生平面破坏,使整体结构沿纵向倒塌,柱被动成铰,结果呈现“弱柱强梁”的层屈服破坏现象。

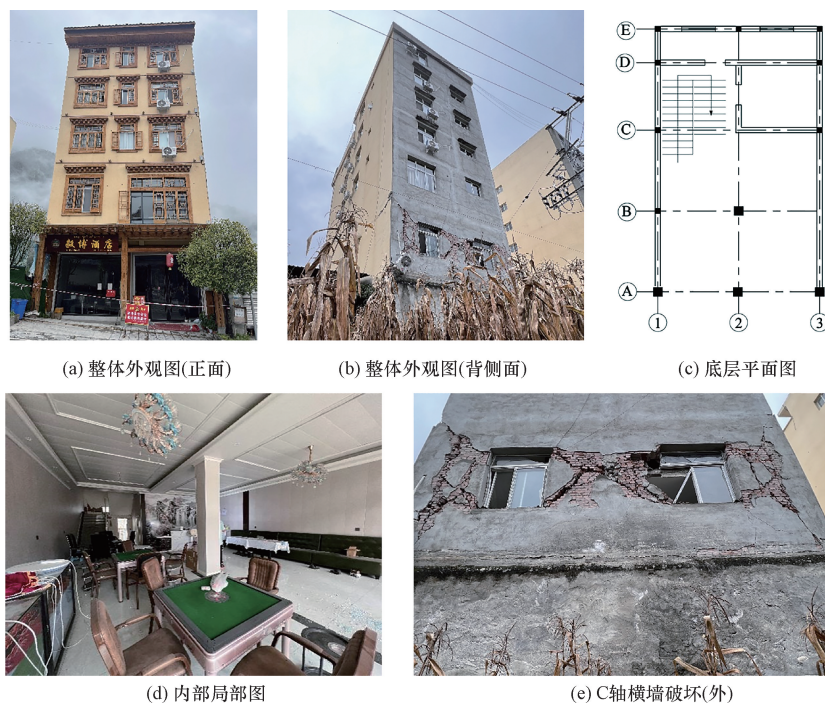
图3 毅博酒店震害

毅博酒店位于磨西镇海螺沟大道,是一栋五层(局部六层)底商建筑,整体外观如图3(a)、图3(b)所示。横向三道轴线:①、③两道轴线是不开洞的含构造柱砌体承重墙,②轴A、B为混凝土柱,底层

平面如图3(c)所示。纵向5道轴线:A轴和B轴局部为混凝土柱,C轴、D轴为开门洞的砌体墙,E轴为开窗洞的砌体墙。震害集中在底层,横墙基本完好,纵向破坏严重。如图3(d)所示,纵向A轴和B轴构件基本完好,C轴D轴墙体剪切破坏,最严重的是E轴窗间墙,X形裂缝将窗间墙分隔成4个三角形块体,左右两侧楔形块体外移导致了铝合金窗户挤压变形,如图3(e)所示,上下两块高度相对缩短,显示楼板已经下坠,结构接近倒塌。

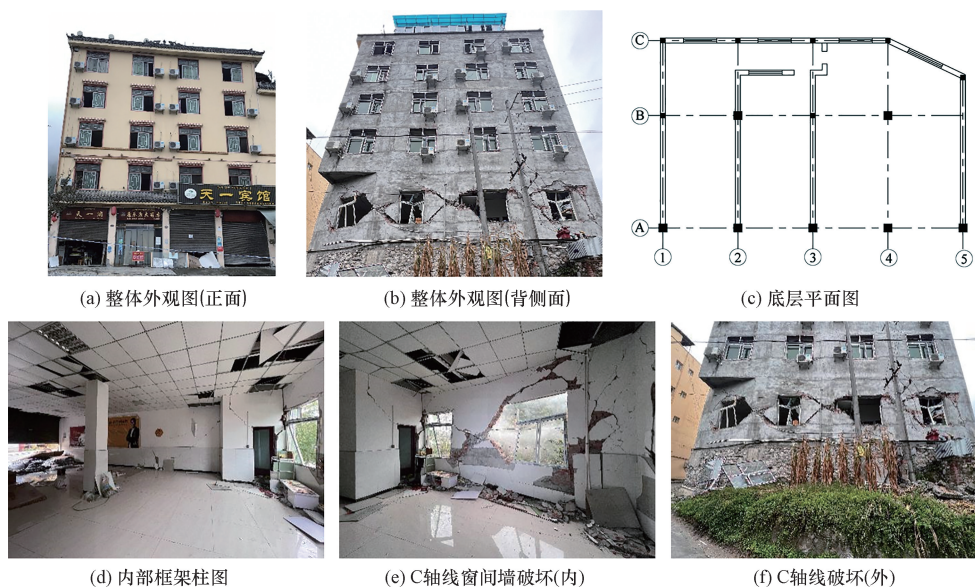
图4 天一宾馆震害

天一宾馆与毅博酒店相距约50 m,是一栋五层底商建筑,正面和背面如图4(a)、图4(b)所示。图4(c)所示的底层平面图显示,横向共五道轴线,除④轴外,其他各轴都有不开洞的砌体墙。纵向由三道轴线构成,A轴和B轴局部是混凝土柱,柱间和墙间空旷,C轴为开窗洞的砌体墙。震害集中在底层,横向破坏轻微,纵向破坏严重且差异明显。关键在于纵向A、B轴框架柱破坏不明显,如图4(d)所示;而C轴线的窗间墙发生了严重的剪切破坏[图4(e)、图4(f)],X形裂缝扩张明显,窗户受挤压变形,楼板下坠。

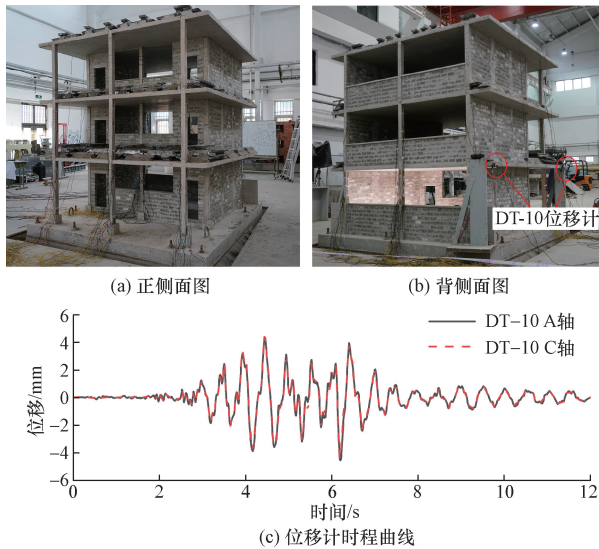
图 5 振动台实验
Fig. 5 Shaking table test

型在底层楼板纵向两侧布置了精密的 DT-10 型位移计, 结构在模拟地震作用下(输入卧龙地震波, 含 X、Y 和 Z 向), 得到了两个位移计的反应曲线 [图 5(c)], 两个测点的位移几乎重合, 这说明楼板没有扭转, 横向的层间位移小到难以识别, 楼板只有纵向平动^[18]。

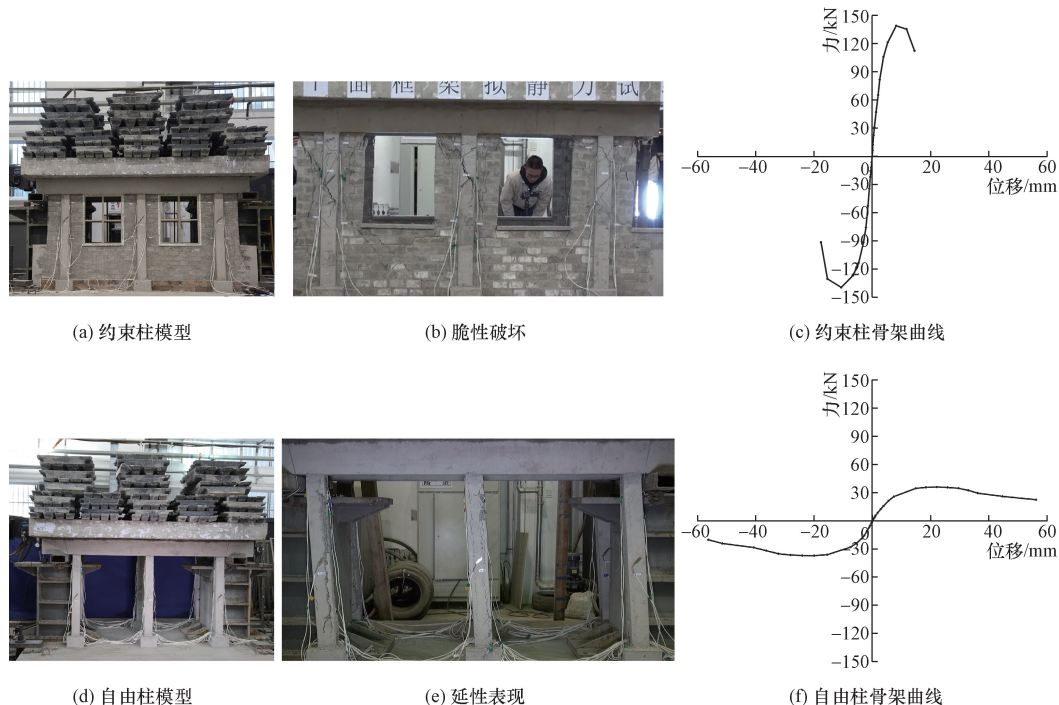
图 6 拟静力实验
Fig. 6 Quasi-static test

柱和约束柱为代表, 制作了两组 1:4 比例的缩尺模型 [图 6(a)、图 6(d)] 构件展开了拟静力实验^[21], 得到两类构件的力-变形关系曲线, 进一步观察和分析了其破坏模式。从拟静力实验得到的骨架曲线 [图 6(c)、图 6(f)] 可以看出, 墙柱组合构件的曲线又高又陡, 侧移很小时就发生了剪切破坏 [图 6(b)], 把这类构件称为硬脆构件。相反, 自由柱的力-位移曲线低缓而绵长, 变形很大时柱身尚且完整, 延性较好 [图 6(e)], 将这类构件称为弱延构件。依据骨架曲线将这两类构件在初始阶段 0.4 mm 振幅工况时计算其抗侧刚度, 得到的硬脆构件刚度是弱延构件的约 8 倍, 刚度差异巨大^[18]。将这两类构件混搭在同一楼层中, 导致结构刚度不均出现了“偏”的缺陷。

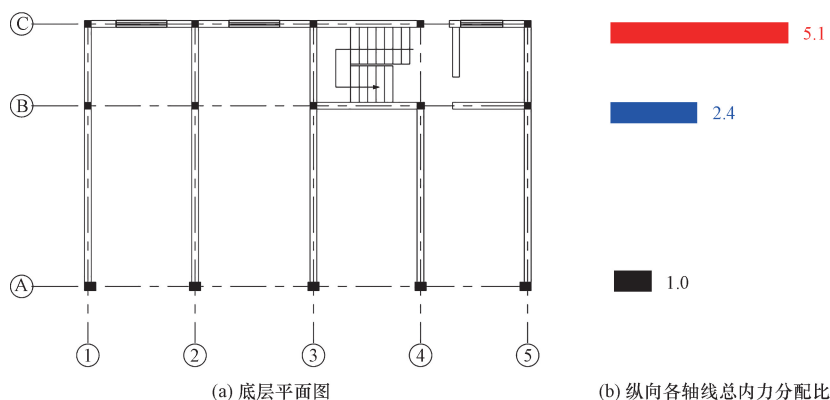
图7 内力分配图

由于此类建筑在地震作用下楼板沿纵向平动为主, 底层的各竖向构件纵向侧移基本一致, 构件所承担的地震剪力与其刚度成比例, 这就导致纵向由硬脆构件和弱延构件组成的轴线内力分配差异巨大(图 7), 硬脆构件侧移很小时就粉碎性破坏, 而此时弱延构件分担的剪力很小, 没有任何破坏。

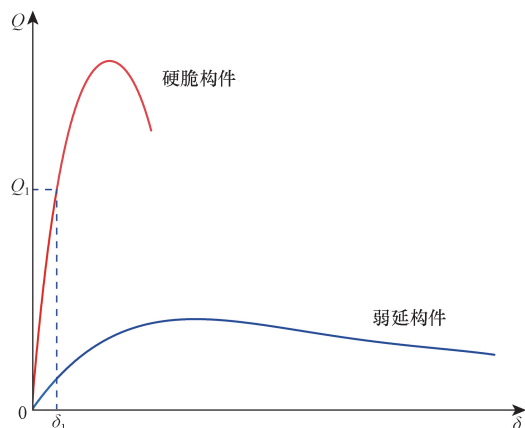
图8 内力凝聚

将硬脆构件和弱延构件的力-变形($Q-\delta$)曲线画在同一坐标系下, 如图 8 所示, 在初始阶段, 所有构件都处于弹性阶段, 侧移很小时, 硬脆构件分担的地震剪力是弱延构件的若干倍, 将这种现象称为“内力凝聚”。侧移继续加大到图 9 所示的状态时,

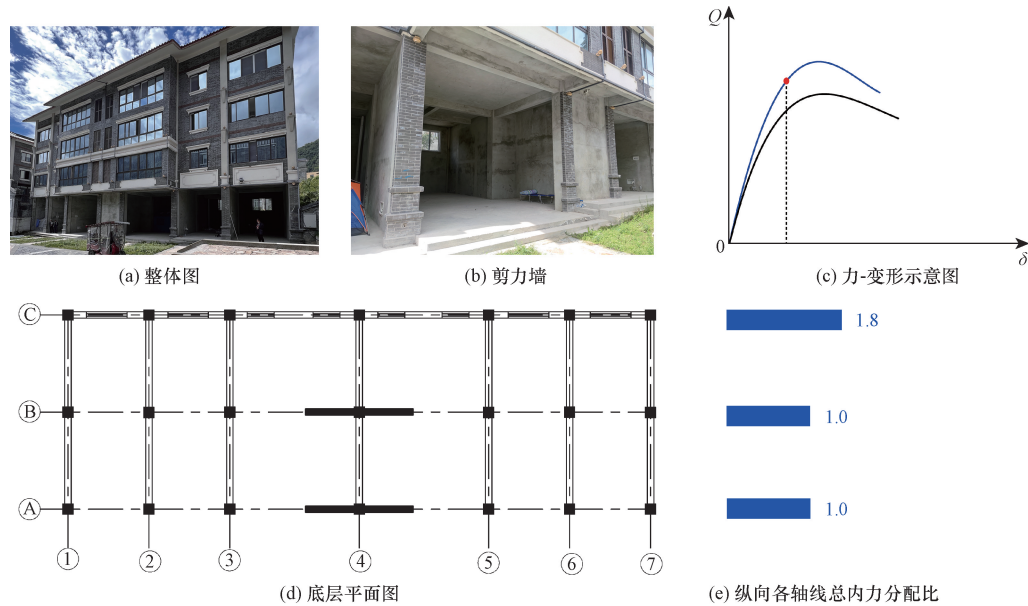
图10 天主教堂旁边民居

在震区内也有表现良好的建筑,经仔细调查发现,表现好的建筑都避免了“偏”的缺陷。磨西镇天主教堂旁边一栋底商建筑在泸定地震后完好。该建筑为四层底框架结构[图10(a)],底层横向多道轴线皆由满砌填充墙组成;纵向三道轴线,C轴线开窗洞,A、B轴线横墙之间空旷,但是在横向A、B轴线中间都设置了一道纵向落地剪力墙,如图10(b)所示。两道落地剪力墙的设置大大降低了纵向各轴线之间的刚度差异,因此,地震剪力分配较为均

衡[图10(e)],地震作用下就不会产生内力凝聚,进而各构件也不会达到变形饱和[图10(c)],构件变形都在弹性范围内,震后没有任何裂缝。

脆性构件在侧移很小时就严重破坏,此时弱延性构件的延性优势并未发挥。这类底商多层建筑的最大缺陷体现在“偏”,而避免了“偏”的房屋在地震中就表现良好,原因是结构布置刚度均衡,各构件未达到变形饱和。由此在新建房屋的抗震设计和原有缺陷的房屋抗震加固中用刚度均衡的理念进行设计,就会使房屋韧性增强,避免严重的人员伤亡和财产的损失。
