# Seismic damage and intensity analysis of conventional railways

Wentao Sun, Yan Xuan, Peng Zhang, Xueying Zhou, Youbiao Wang,  
Yanzhang Liu and Xia Wang

*Railway Science and Technology Research and Development Center,  
China Academy of Railway Sciences Corporation Limited, Beijing, China*

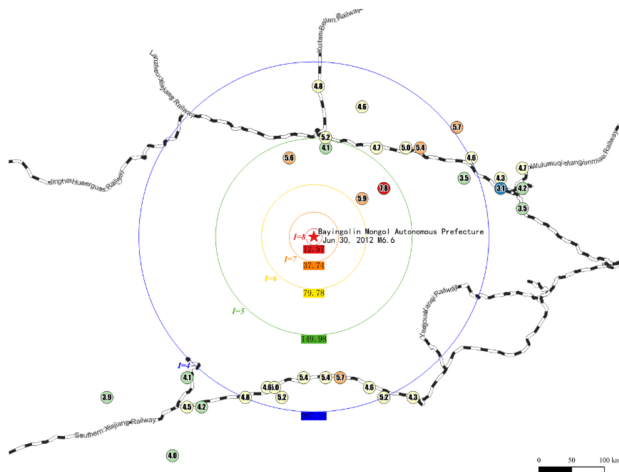
**Figure 1.** Distribution map of seismic intensity and railway lines for the M6.6 earthquake in Bayingolin Mongol autonomous prefecture. Source: Authors' own work

Based on measured instrumental intensity and calculated intensity from attenuation formulas, the maximum seismic intensity affecting railway lines during this event did not exceed Intensity VI, with most areas experiencing Intensity V. Corresponding impacts included subgrade cracking and damage to bridge limiters.

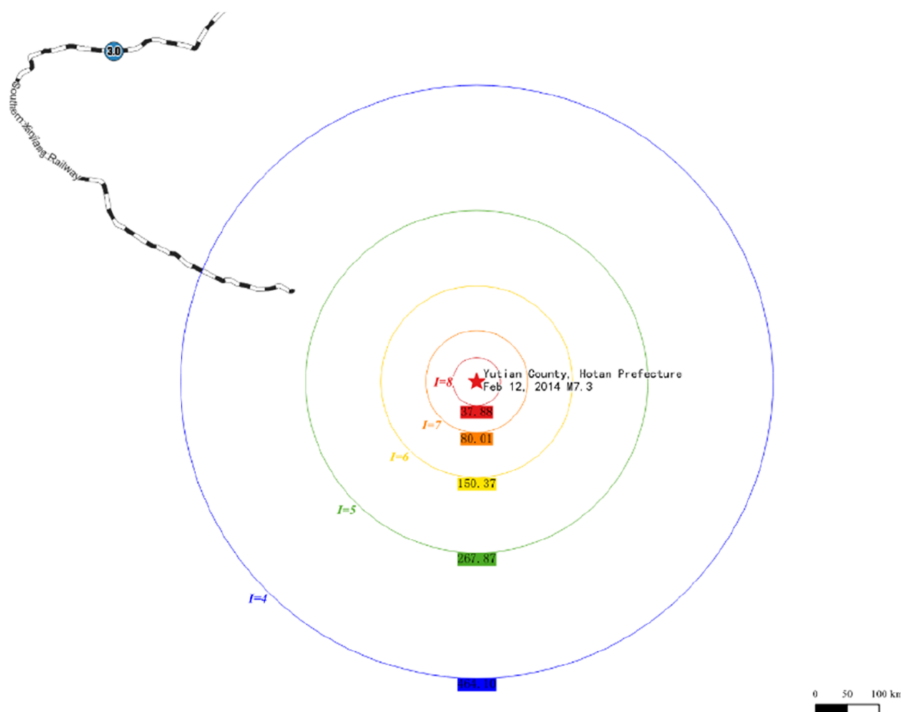
**Figure 2.** Distribution map of seismic intensity and railway lines for the M7.3 earthquake in Yutian county, Hotan prefecture. Source: Authors' own work

Based on measured instrumental intensity and calculated intensity from attenuation formulas, the maximum seismic intensity affecting railway lines during this event did not exceed Intensity V, with most structural damage concentrated in Intensity V zones. Corresponding impacts included: longitudinal cracks and subsidence of subgrade slopes with varying severity, alterations in track geometry; damage to ancillary facilities such as bridge/culvert protective cones and diversion embankments; failure of seismic protection devices on bridges; concrete spalling from girders and cracking in transverse diaphragms; and ballast loss observed even in Intensity IV zones. These findings demonstrate how intensity-based damage patterns can inform targeted post-earthquake inspection strategies.

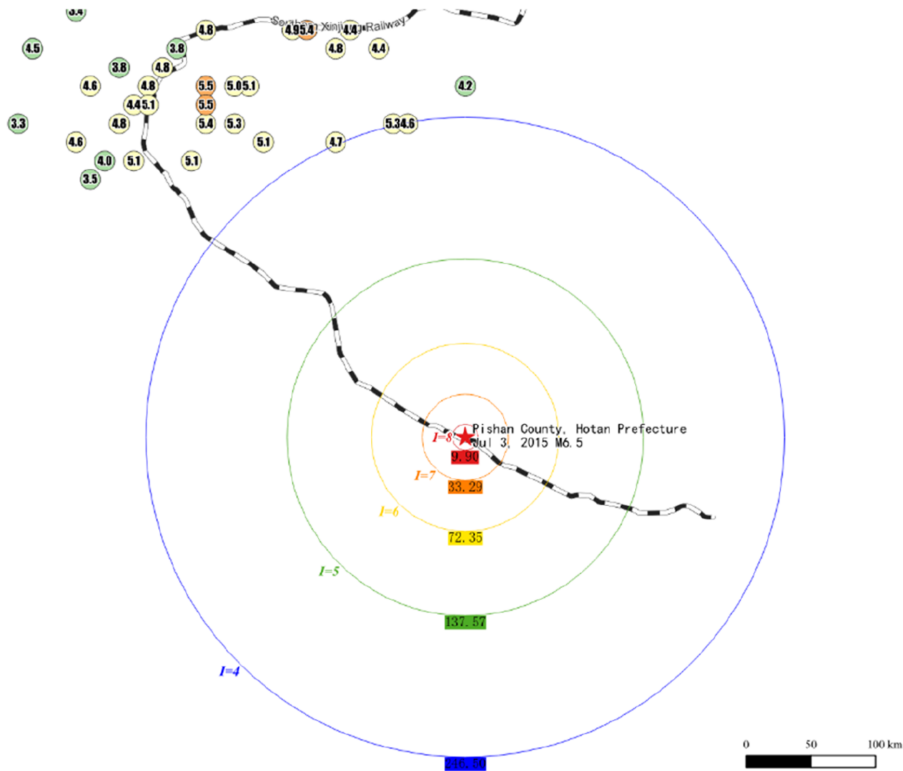
**Figure 3.** Distribution map of seismic intensity and railway lines for the M6.5 earthquake in Pishan county, Hotan prefecture. Source: Authors' own work

Based on measured instrumental intensity and calculated intensity from attenuation formulas, the maximum seismic intensity near railway lines during this event reached Intensity VIII, with damage predominantly concentrated in Intensity V-VIII zones. The seismic impacts caused differential settlement of subgrade slopes, lateral displacement and shearing of bridge bearings, as well as cracking and failure of bridges, culverts, and ancillary facilities. These

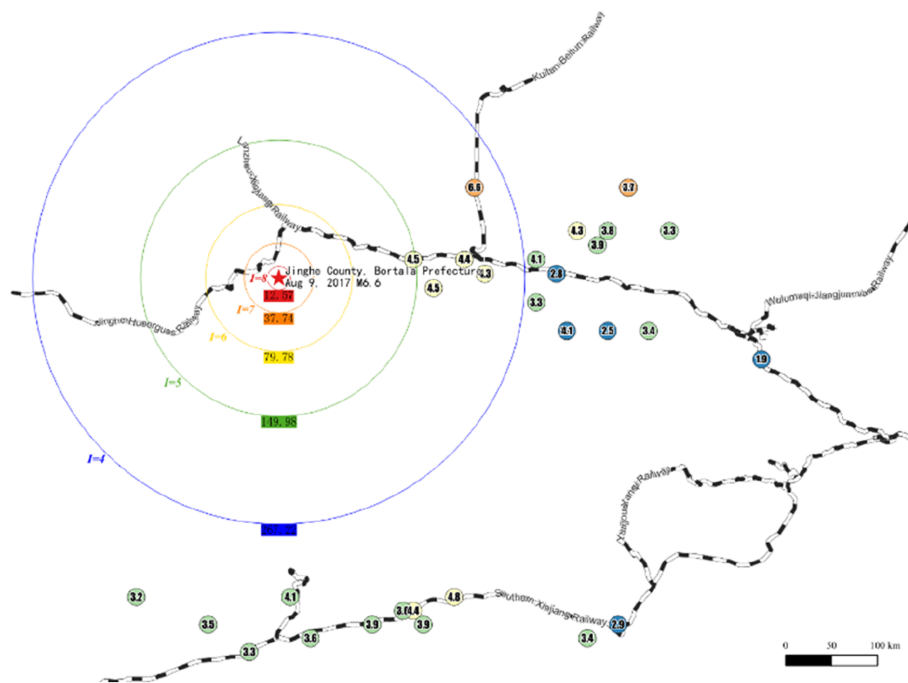
**Figure 4.** Distribution map of seismic intensity and railway lines for the M6.6 earthquake in Jinghe County, Bortala Mongol Autonomous prefecture. Source: Authors' own work

Based on measured instrumental intensity and calculated intensity from attenuation formulas, the maximum seismic intensity near the railway lines during this event reached Intensity VIII, with the most severe damage concentrated in Intensity VII-VIII zones. This resulted in significant deterioration of track geometry, cracking and failure of bridge protective cones and pier/beam restraint devices, fracture of tunnel portal structures, as well as broken catenary support poles and severed contact wires.

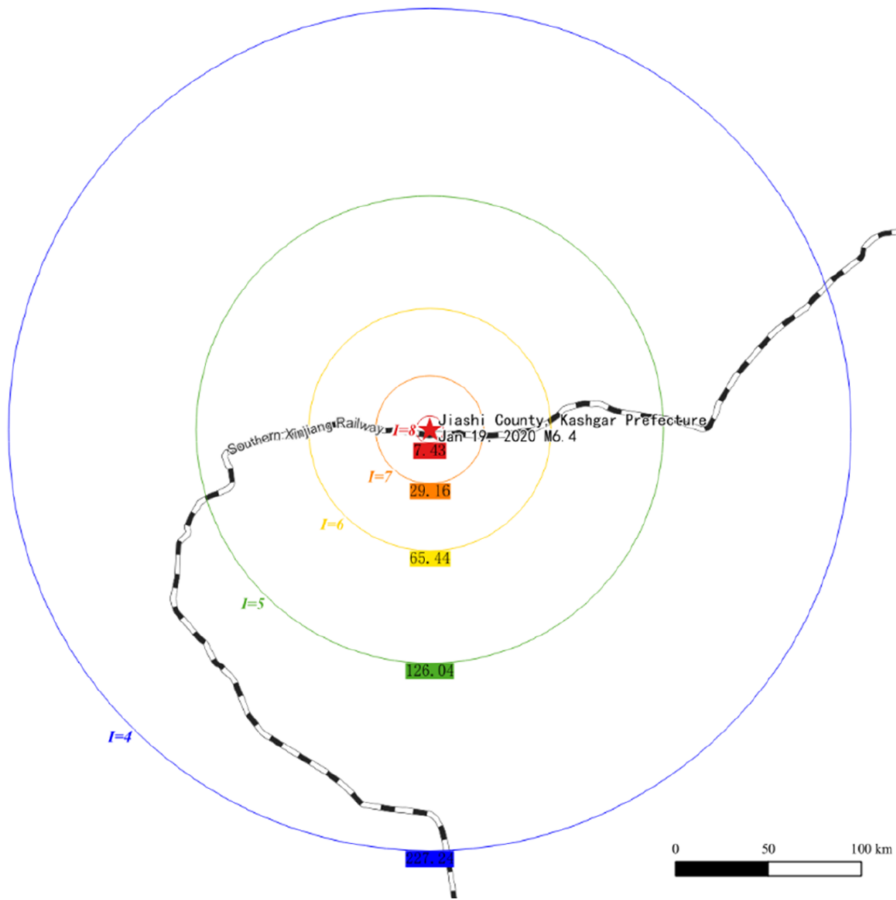
**Figure 5.** Distribution map of seismic intensity (acceleration) and railway lines for the M6.4 earthquake in Jiashi County, Kashgar prefecture. Source: Authors' own work

Based on the calculations of measured instrumental intensity and intensity derived from the attenuation formula, it is known that the seismic intensity at the closest points of various railway lines during this earthquake reached Grade VIII. Most severely damaged areas were concentrated in Intensity VI-VIII zones. The damages mainly included: displacement of bridge girders and bearings; uneven settlement, heaving of railway tracks; scattering of ballast, ballast shortage in the track bed; settlement, heaving, cracking, and step displacement of subgrades; structural cracks in bridge piers and abutments; damage to bridge protection cones; severe cracking of station buildings; and collapse of enclosing walls.

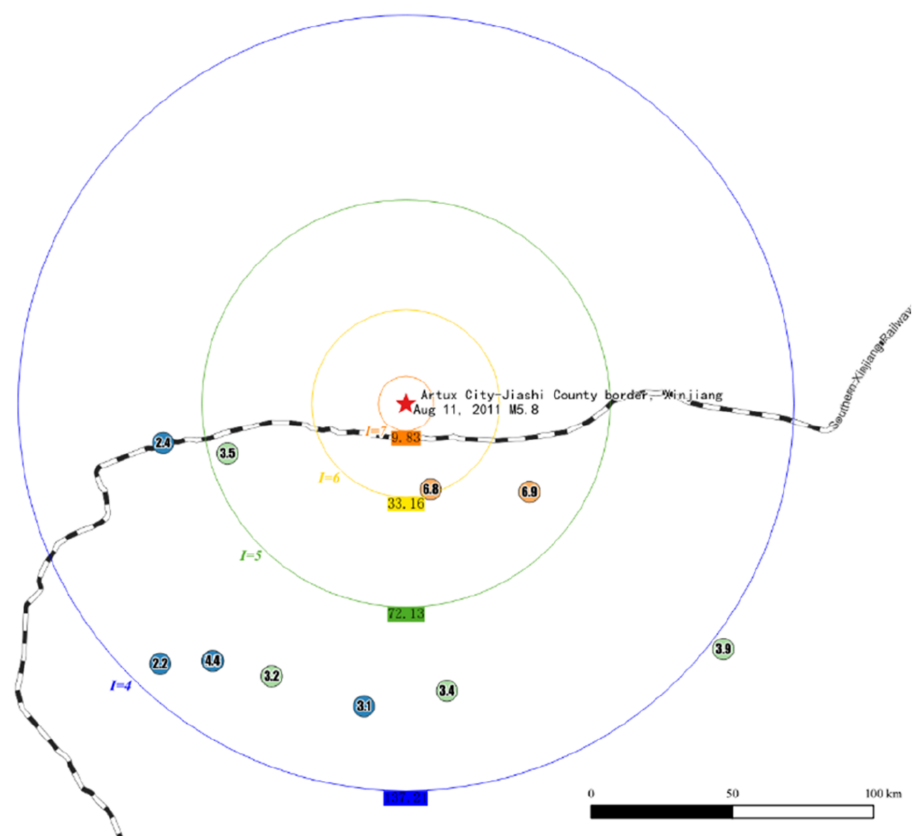
Figure 6. Distribution map of seismic intensity and railway lines for the M5.8 earthquake at the border of Artux City and Jiashi County, Xinjiang. Source: Authors' own work

According to calculated intensity from attenuation formulas, the maximum seismic intensity near the railway lines during this event reached Intensity VII, with the most severe damage concentrated in Intensity VI-VII zones. The impacts on the Southern Xinjiang
