# Seismic damage characteristics and resilience design of cross-fault tunnels: New insights from the Daliang Tunnel in the 2022 Menyuan $M_W$ 6.6 Earthquake

An earthquake with a magnitude of 6.6 ( $M_W$ ) occurred in Menyuan County, Qinghai Province, China, on January 8th, 2022. The Daliang Tunnel, which traverses the seismogenic fault, was severely damaged during this seismic event. The seismic damage investigation of the tunnel is introduced, and the damage characteristics along the tunnel are also presented. It is found that the damage severity of the tunnel is highly correlated with the distance to the fault. Damage modes for different tunnel zones (cross-fault zone, portal zone, and ordinary zone far from the fault and the portal) are quite distinct. Based on the understanding of seismic damage to the Daliang Tunnel in 2022 Menyuan Earthquake, as well as other damaged tunnels during the 2008 Wenchuan Earthquake, the critical influence factors for damage to cross-fault tunnels are discussed. From the seismic investigation, coupling effects of strong ground motions and fault dislocations are highlighted, which pose significant risks to cross-fault tunnels and should be consider

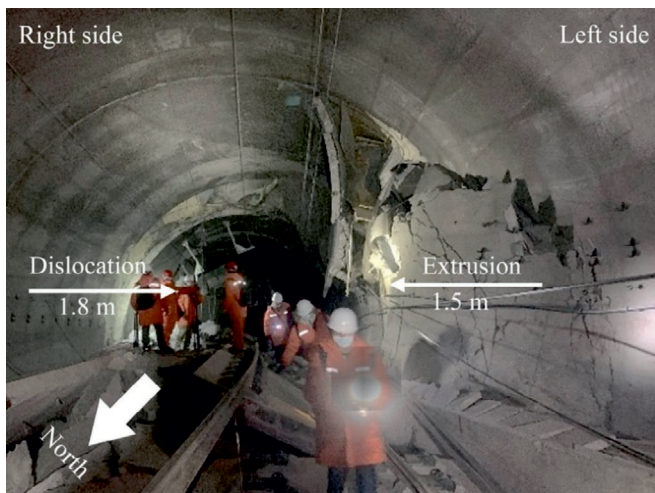
Fig. 5. Dislocation and collapse of lining.

Figure 5 shows the most severely damaged part of the tunnel across the fault, where it is clearly visible that the left hence of the tunnel lining completely collapsed, with the secondary lining of the left sidewall squeezed inward by approximately 1.5 m. The deformation joint of the right sidewall of the tunnel has a distinct lining dislocation with a magnitude of 1.8 m.

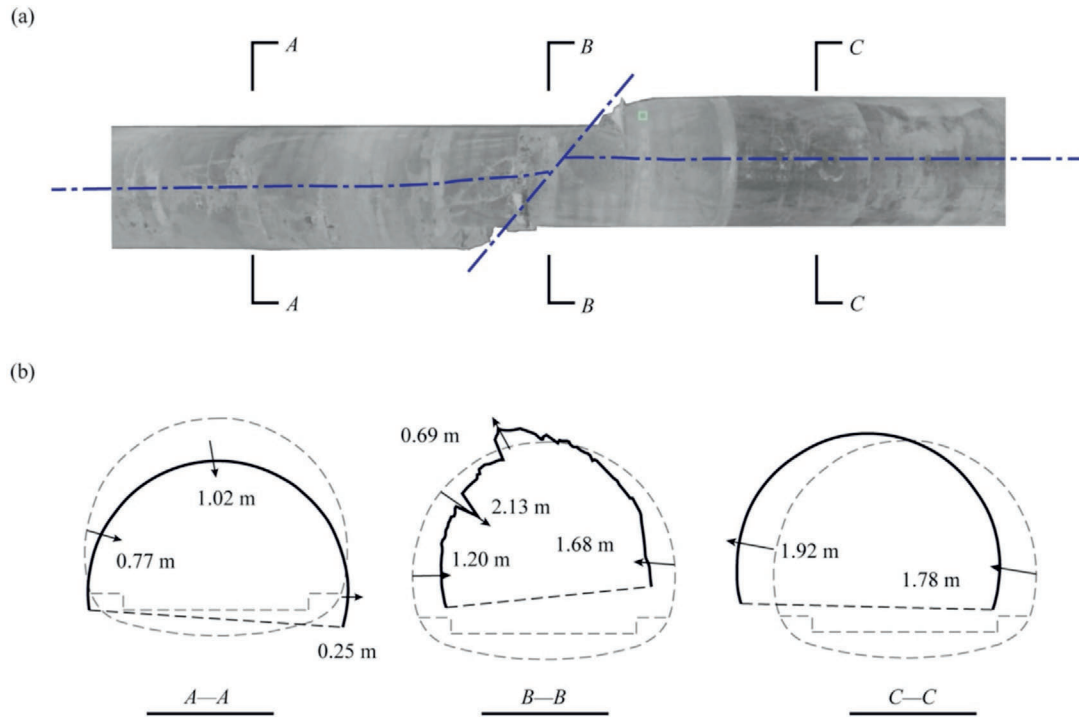
Fig. 6. Post-earthquake 3D laser scanning of (a) tunnel lining, and (b) deformed cross sections.

Figure 6(a) shows the post-earthquake deformation distributed along the tunnel axis. The lining dislocation was concentrated within the 21 m zone, ranging from K1971+390.4 to K1971+411.7, located near the interface between

the fault and the hanging wall. The angle of intersection between the dislocation rupture and tunnel axis was about 50°. The lateral dislocation along the tunnel ranged from 1.5 to 2.0 m, and the longitudinal dislocation ranged from 0.3 to 0.8 m, due to the fault movement.

Figure 6(b) displays the deformation characteristics of different tunnel cross-sections along their length. It can be observed from the figure that tunnel sections close to the fault rupture plane exhibited an oval deformation due to the compression from surrounding rocks. In contrast, other sections far away from the rupture plane were only affected by the ground motion, and there was no obvious deformation.

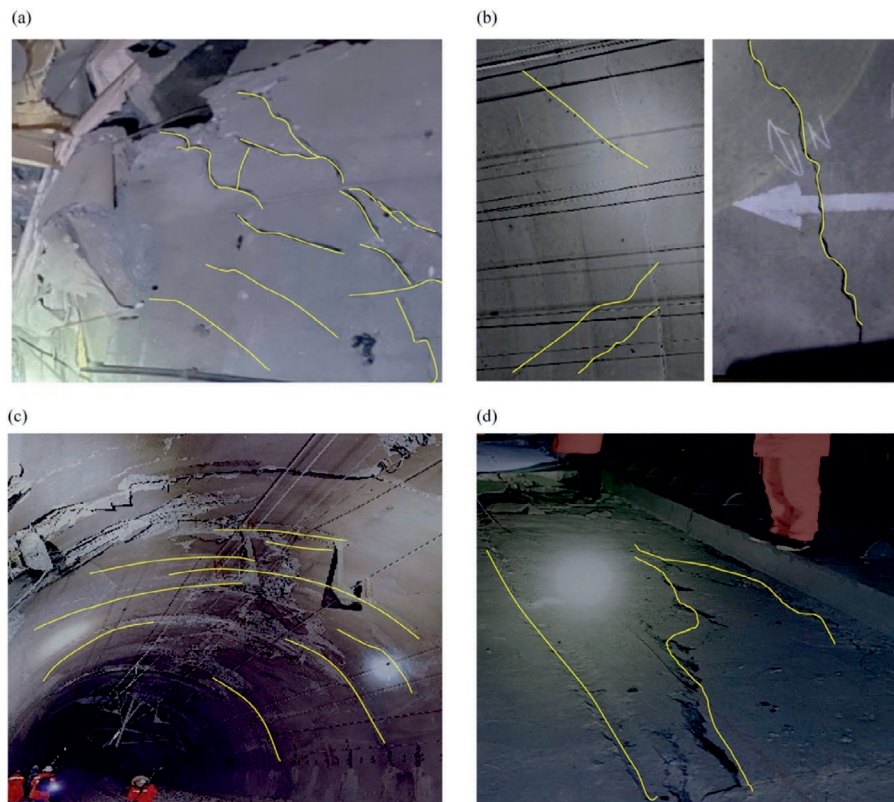
Fig. 7. Four types of cracks. (a) Reticular cracks, (b) inclined cracks, (c) circumferential cracks, and (d) longitudinal cracks.

Lining cracks were distributed throughout the entire tunnel and exhibited different patterns in various zones. These cracks can be categorized into four main types: reticular cracks, inclined cracks, circumferential cracks, and longitudinal cracks, as shown in Fig. 7. Reticular and inclined cracks were the most concentrated crack patterns, which were mainly observed within the range from K1971+295 to K1971+695 close to the LLL Fault, where the lining suffered from compression and shear forces due to the fault dislocation effect. Circumferential cracks were the most widely distributed cracks along the tunnel lining, and most of these cracks were short and localized, primarily observed on the sidewalls and invert of the tunnel. However, several circumferential cracks near the fault were notably longer, almost forming complete rings. These longer cracks were often accompanied by concrete lining spalling. Longitudinal cracks usually appeared on the track beds after track lifting, affected by the fault movement.

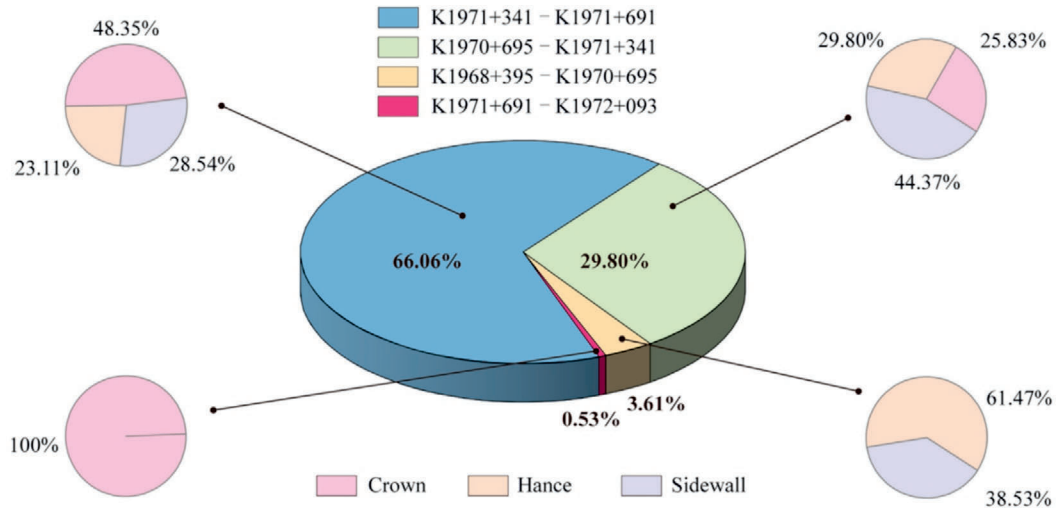
Fig. 8. Distribution of spalling. (Data from Zhang et al. (2022))

The distribution of lining spalling was highly concentrated in specific sections of the Daliang Tunnel. Approximately 96% of the total lining spalling area occurred within a 996 m-long zone ranging from K1970+695 to K1971+691, as illustrated in Fig. 8. This zone was entirely located in the region of the IX-degree intensity and crossed the LLL Fault. Note that 295 m of that was situated within the fault zone, while 690 m was in the hanging wall and 11 m in the footwall. The remaining spalling was scattered over a large area extending more than 5 km along the tunnel, but occurred in much smaller quantities.

Figure 8 also highlights the distribution of lining spalling at different tunnel sections along the tunnel. It can be seen from the figure that lining spalling was mainly observed on the tunnel crowns from K1970+695 to K1971+691, accounting for nearly 40% of the total spalling area, followed by the side walls with around 30%. In the range from K1970+695 to K1971+691, the lining spalling was continuous and extensive, often accompanied by reticular and inclined cracks (Fig. 9(a)). In other zones, the lining spalling was more sporadic, mainly concentrated around deformation joints (Fig. 9(b)).

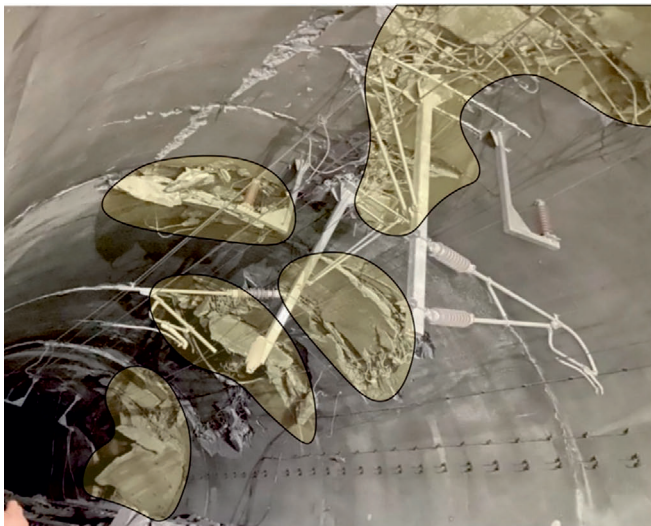
Fig. 9. Concrete spalling observed on (a) arches, and (b) along deformation joints.

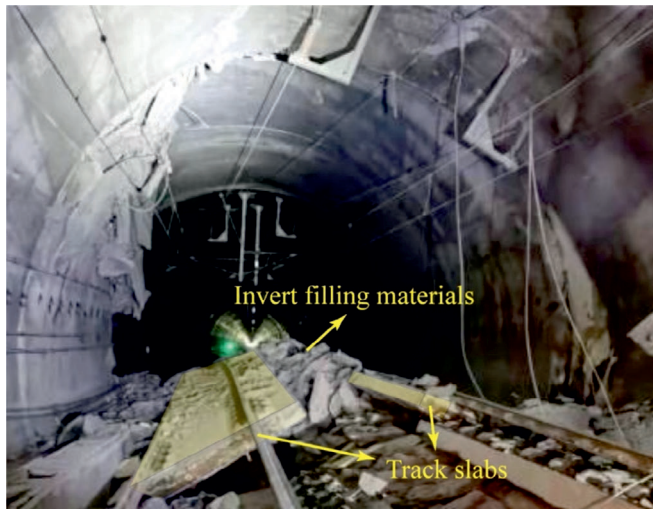
Fig. 10. Invert uplift.

The invert uplift was mainly observed in a 350 m range in the vicinity of the LLL Fault, which led to significant damage to many non-structural members. Distribution of the invert uplift coincided with that of the lining dislocation, extending from K1971+341 to K1971+691.

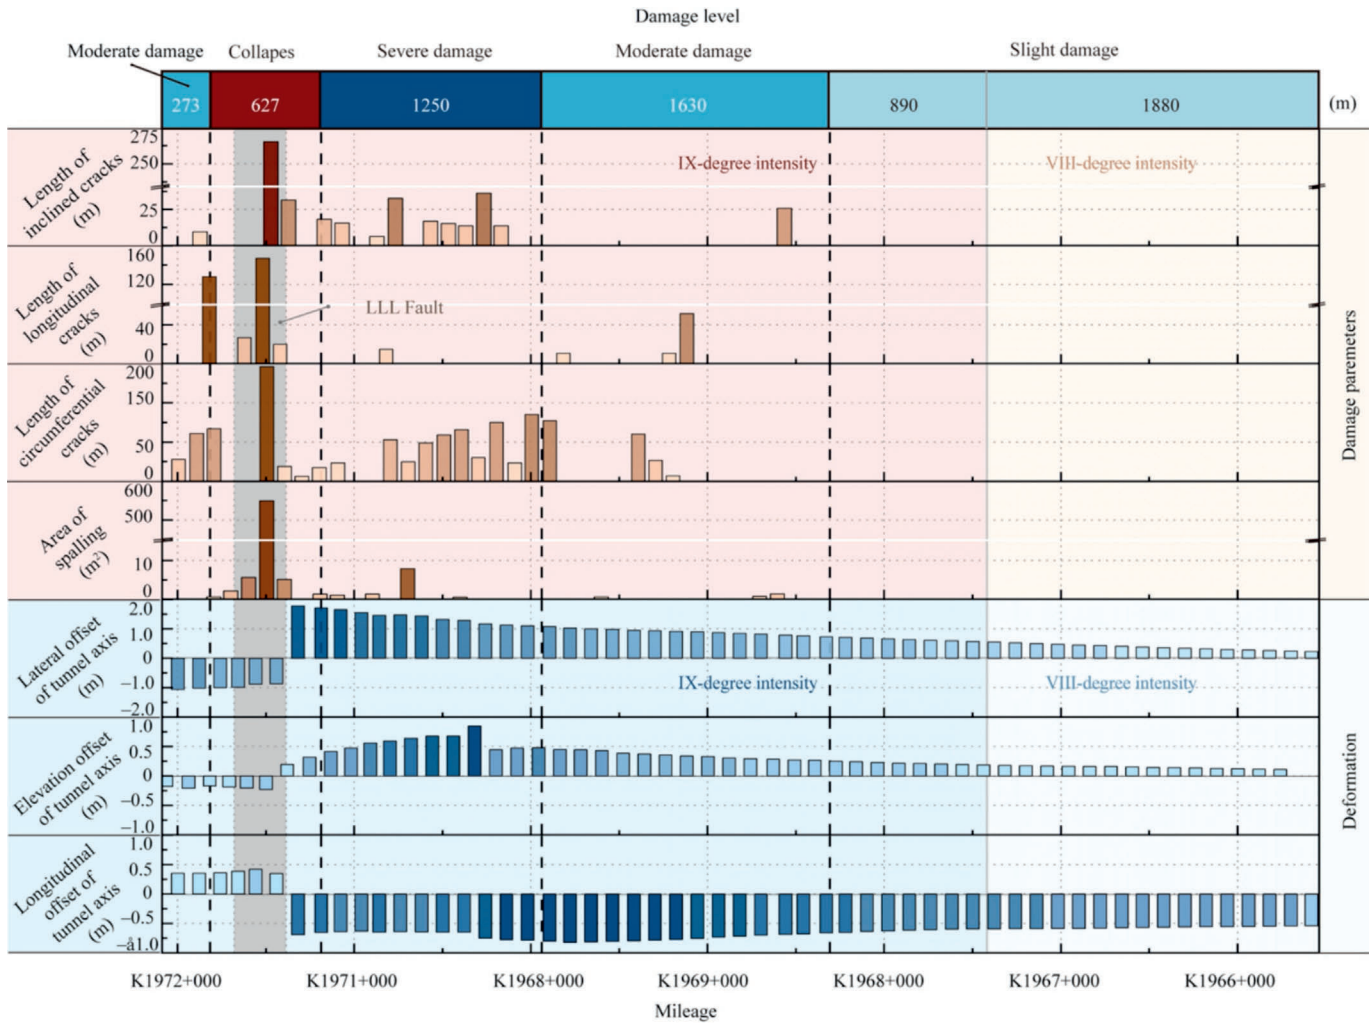
Fig. 12. Damage assessment and distribution of damage parameters and deformation. (Data from Zhang et al. (2022))

The distribution of assessment results and related parameters along the Daliang Tunnel is illustrated in Fig. 12. The most damaged sections, rated as collapse (V), spanned a total of 627 m, crossing the LLL Fault. Of this, 295 m lay entirely within the fault zone, with 197 m in the hanging wall and 135 m in the footwall. The tunnel sections assessed as severe damage (IV) were entirely located on the hanging wall and extended over 1250 m. Meanwhile, the rest of the 4673 m-long tunnel sections along the tunnel axis suffered from moderate (III) or only light damage (II).

The relationship between seismic damage of the tunnel lining and earthquake intensity is plotted in Fig. 12. It can be clearly observed from the figure that the tunnel section with a total length of 1880 m located in the VIII-degree intensity zone experienced only slight damage or remained intact, while the tunnel section situated in the IX-degree intensity zone was slightly to severely damaged and partially collapsed.

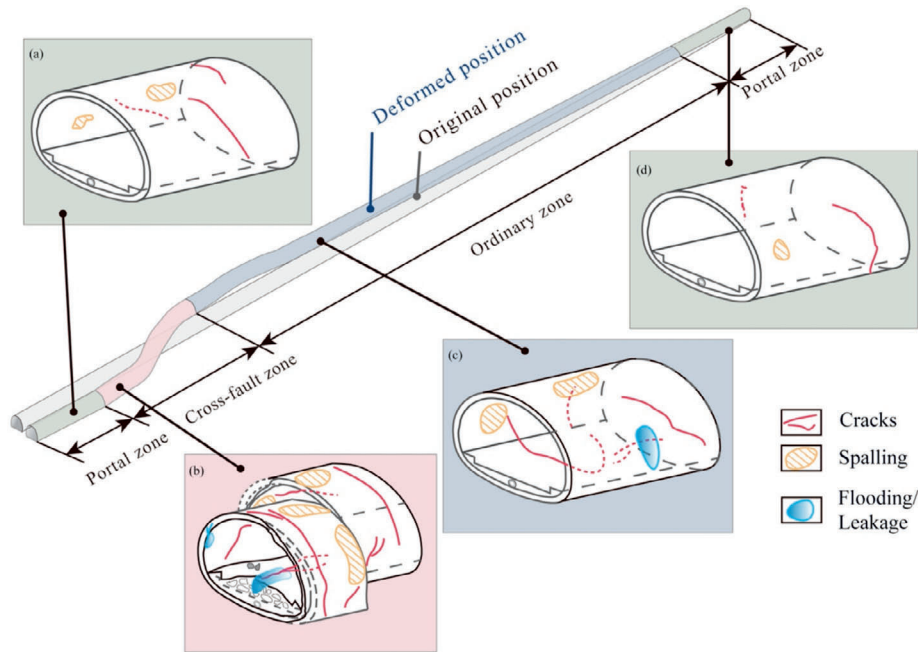
Fig. 13. Structural damage mode of each zone. (a) The northern portal zone, (b) cross-fault zone, (c) ordinary zone, and (d) the southern portal zone.

Clearly, the cross-fault section of the Daliang Tunnel suffered from the most severe damage, with the seismic damage to the entire section being evaluated as collapse (Fig. 13(b)). More specifically, the tunnel lining in this section experienced significant meter-level deformations, including lining dislocations and invert uplifts, along with non-structural failures such as electrical system breakdowns and flooding. Extensive and continuous concrete spalling was observed around the tunnel arch, and the cracks in the lining primarily appeared as reticular and inclined cracks, with some circumferential cracks also present.

Seismic damage patterns for the ordinary section of the tunnel are plotted in Fig. 13(c). Although the extent of damage varies due to differences in distance from the fault, the type of damage remains relatively consistent across this section. The observed damage for this tunnel section included concrete spalling, lining cracks, and leakage. Note that cracks in this section were primarily distributed in the circumferential and inclined forms, with a few longitudinal cracks. Comparatively, the portal sections of the Daliang Tunnel were less damaged. Both portal sections displayed a consistent damage mode characterized by localized spalling and circumferential cracks (Fig. 13(a) and (d)).

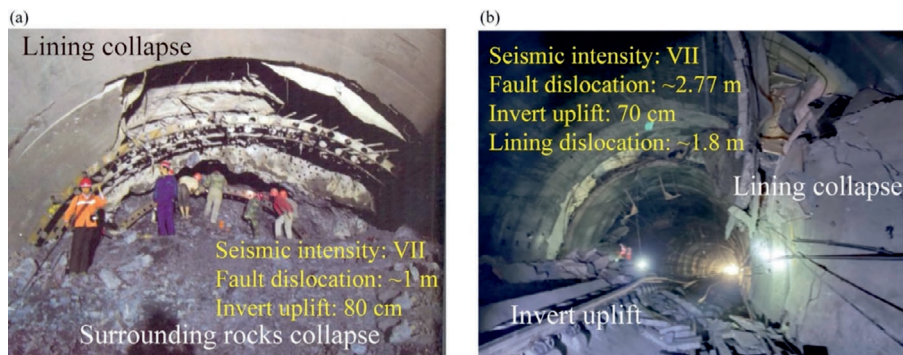
Fig. 15. Damage of the cross-fault zone in (a) Longxi Tunnel (Yu et al., 2016a), and (b) Daliang Tunnel.

Figure 15 illustrates the damage patterns of the cross-fault sections of the Longxi tunnel and the Daliang Tunnel, which were seriously damaged tunnels in the Wenchuan Earthquake and the Menyuan Earthquake, respectively. As can be seen from the figure, both the tunnel lining and surrounding rocks of the Longxi Tunnel across the fault completely collapsed, with invert uplift reaching 80 cm; while the cross-fault section of the Daliang Tunnel exhibited only lining collapse, accompanied by a significant 1.8 m lateral lining dislocation and 70 cm invert uplift.

Surprisingly, the Daliang Tunnel did not suffer more severe structural failure, despite experiencing greater fault dislocation than the Longxi Tunnel. This anomalous observation can be attributed to the arrangement of deformation joints in the cross-fault section along the Daliang Tunnel.

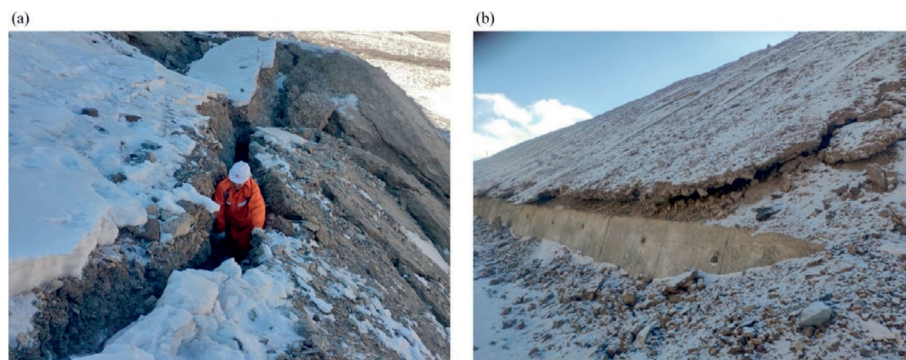
Fig. 19. Slide of slopes along the primary rupture of the LLL Fault. (a) Slope slide observed along the LLL Fault, and (b) slope instability near the Daliang Tunnel site.

Combined with the field investigation near the Daliang Tunnel, it can be concluded that the slope instability may be one of the potential causes for this localized amplification of fault rupture dislocation. Figure 19 shows several landslides distributed along the main surface rupture zone of the earthquake, one of which is located directly on the slope above the Daliang Tunnel. Note that the near-surface soils in this area are loose and unstable, especially near the northern portal of the Daliang Tunnel, with a slope gradient of more than 30%, which can be regarded as a steep slope. As a result, landslides and slope instability are more likely to occur along these major surface ruptures.

fault rupture propagation and gravitational loading, additional mechanical disturbances may trigger local slope instability, leading to the formation of secondary strain concentration zones. With continued rupture evolution, these secondary zones can gradually interact with and eventually connect to the primary fault rupture path,

These observations provide a plausible explanation for the pronounced fault dislocation and severe lining damage observed at the Daliang Tunnel site. The local topographic relief and site-specific geotechnical conditions are strongly
