# The impact of metal cleaning agents on components of air conditioning piping systems in EMUs

**Keywords** Metal cleaning agents, EMU, Air conditioning piping system, Corrosion

**Paper type** Research article

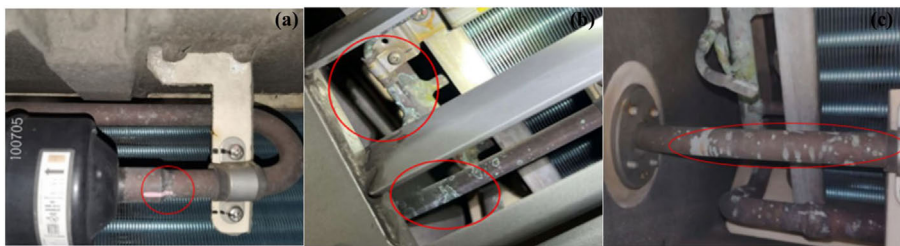
**Figure 1.** (a) Mild corrosion (b) Moderate corrosion (c) Severe corrosion. **Source (s):** Authors’ own work

Air conditioning unit piping, comprising copper tubing (TP2 deoxidised copper) and stainless steel corrugated hoses (304 grade), exhibits corrosion during operation, as illustrated in Figure 1. 3 levels of air conditioning pipe corrosion: Minor corrosion: Small, isolated rust spots cover no more than 10mm<sup>2</sup> with no larger than 16mm<sup>2</sup> areas, and no extensive flaking or accumulation; Moderate corrosion: Extensive, patchy, or block-like rust spots and verdigris are present, but no refrigerant leakage has occurred; Severe corrosion: Beyond moderate corrosion, rust has penetrated the pipe interior, resulting in refrigerant leakage (Bai *et al.*, 2013; Eddy, Ibok, Ebenso, El Nemr, & El Ashry, 2009; El Nemr *et al.*, 2014a, b; El Nemr, Moneer, Khaled, Khaled, & El-Said, 2014; Li, Bae, Mishra, Shi, & Giammar, 2020; Thombare *et al.*, 2022).

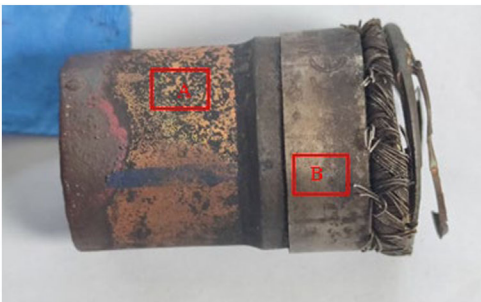
**Figure 2.** Corrosion sample of air conditioning copper tube. **Source (s):** Authors’ own work

The corrosion test specimens of air conditioning copper tube were sourced from Changsha EMU Depot, measuring 40 × 20 mm. Section A represents the tail end of the copper tube, while Section B denotes the head end, as illustrated in Figure 2. The high-pressure shock-absorbing hose for air conditioning compressors was procured from Beijing Zhuoxu Company, measuring 50 × 2 cm, as shown in Figure 3.

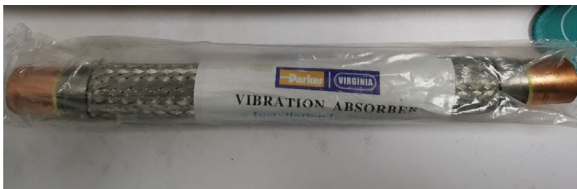
**Figure 3.** High-pressure shock absorber hose. **Source (s):** Authors’ own work

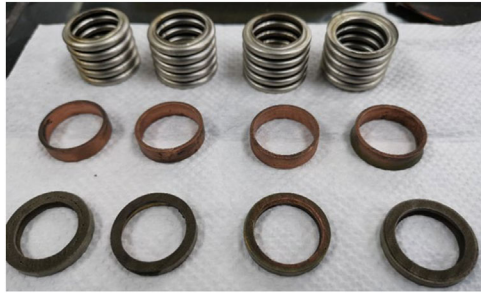
**Figure 4.** Appearance of the sample after cutting the suspension hose of the air conditioning unit. **Source (s):** Authors' own work

Following GB/T1690-2010 “Test Methods for Resistance of Vulcanised Rubber or Thermoplastic Rubber to Liquids” (National Standardization Administration, 2011), the high-pressure shock-absorbing hose of an air conditioning compressor was sectioned into 3 components: corrugated hose (304 stainless steel), pressure-bearing section (carbon steel), and copper tube (TP2 deoxidised copper). Each section underwent full immersion testing in cleaning agents, as illustrated in Figure 4 and detailed in Table 1.
