# Wear of contact strip in high-speed trains: a review

**Paper type** General review

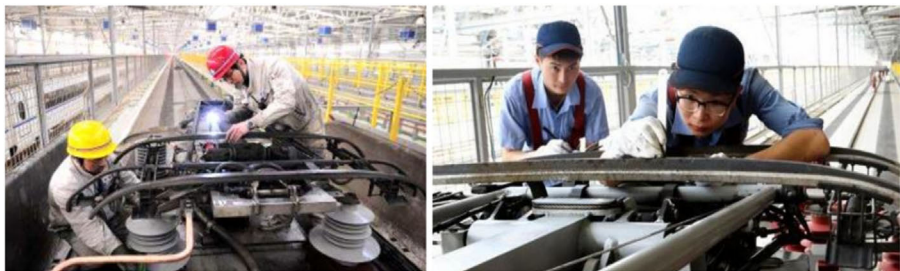
Current methods for assessing CS wear are primarily based on direct measurement techniques. This procedure requires skilled technicians to accurately identify the extent of wear, as illustrated in [Figure 7](#). After the train is brought into the depot and fully de-energized, personnel must climb onto the roof and use specialized measurement instruments to determine the CS thickness, locate worn areas, and evaluate material loss. While this approach is simple and straightforward to implement, it is relatively complex in practice due to the need for power shutdown and manual roof access. Furthermore, measurement results are highly influenced by human factors, introducing potential errors in identifying the most worn regions. In addition, this method only collects thickness values at discrete points, limiting the ability to accurately assess the overall wear morphology of the entire CS surface ([Lu, Liu, Li, & Shen, 2021](#)).

**Figure 7.** Technicians measuring wear on the CS. **Source(s):** [Lu et al. \(2021\)](#)

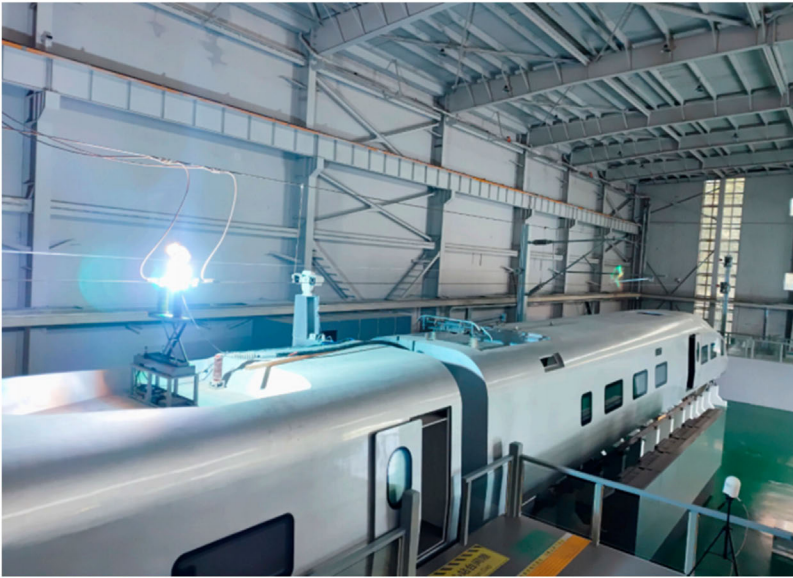
Besides mechanical wear caused by friction, another issue that has received considerable attention and severely affects the CS surface is electrical arcing. Electrical arcs can result in carbon strip erosion, damage to the CL, and interruption of power supply, while also generating interference in communication signals, which directly impacts train operation and poses a threat to operational safety.

**Figure 10.** Arc phenomenon between the CL and pantograph. **Source(s):** [Yang et al. \(2024b\)](#)
