Influencing factors and countermeasures of aging and yellowing on windshield rubber in high-speed train

Purpose – Regarding that Ultraviolet radiation, pollutant adsorption, and environmental changes may be the main reasons for the aging and yellowing on windshield rubber in high-speed trains, countermeasures are proposed to solve the aging and yellowing of windshield rubber and reduce the adverse effects caused by rubber yellowing.

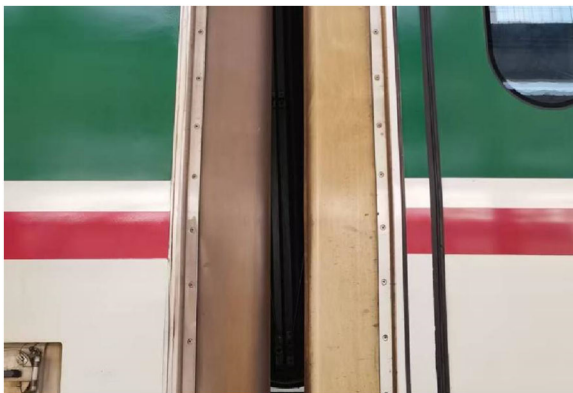
Windshield yellowing is primarily caused by the combined effects of environmental aging and material properties. Ultraviolet radiation triggers photo-oxidative degradation of

Figure 1. Yellowing of windshield rubber. **Source(s):** Author's own work

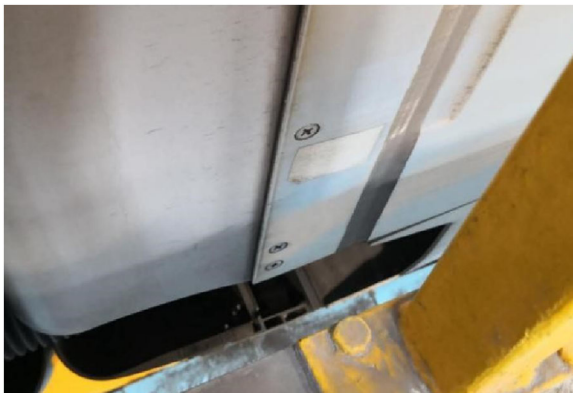
Collect contaminants adhering to the outer surface of the high-speed train, and apply adhesive tape near the windshield position as shown in Figure 4. After sampling, analyze the main components of the contaminants (comparing the blank adhesive tape before testing with the contaminated adhesive tape after testing), as shown in Table 1 and Figure 5.

Figure 4. Adhesive tape application. **Source(s):** Author’s own work

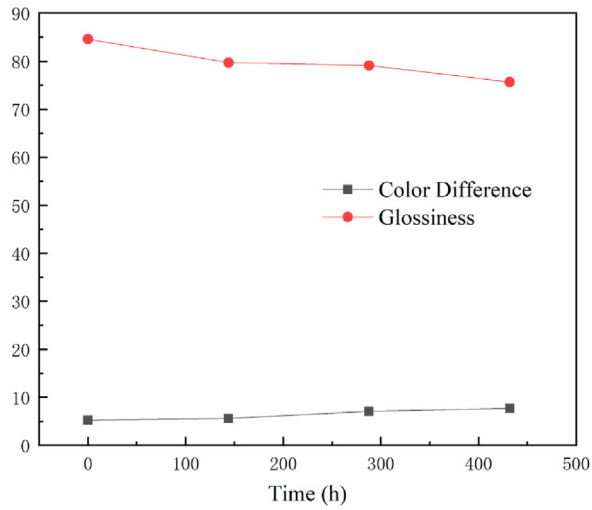
Windshield rubber specimens coated with water showed minimal changes in color difference and light color after 432 hours of salt spray aging, indicating that the effect of salt spray aging on the rubber specimens was negligible, as shown in [Figures 13 and 14](#).

Figure 13. Gloss and color difference of windshield rubber after salt spray aging. **Source(s):** Author's own work

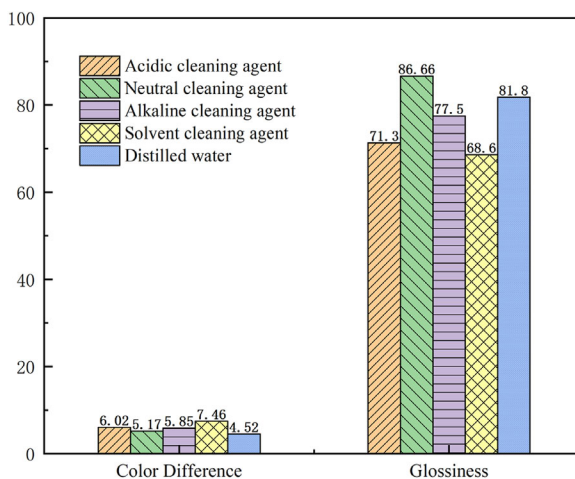
Figure 15. Gloss and color difference of windshield rubber after immersion in different cleaning agents for 5 days. **Source(s):** Author's own work

cleaning agents. Prolonged contact with solvents causes non-polar solvents to penetrate the rubber network, weakening intermolecular forces and causing surface swelling, resulting in the greatest hardness change. However, in this test, the quality change rate and hardness change values of the windshield rubber are similar to those of distilled water and within reasonable ranges. It is inferred that the main components of the cleaning agents are non-ionic surfactants, additives, and corrosion inhibitors, with extremely low additions of acidic, alkaline, or solvent substances. Therefore, after dilution, the effective content is extremely low, and it can be considered that diluted acidic, alkaline, and solvent cleaning agents have a minimal impact on rubber.

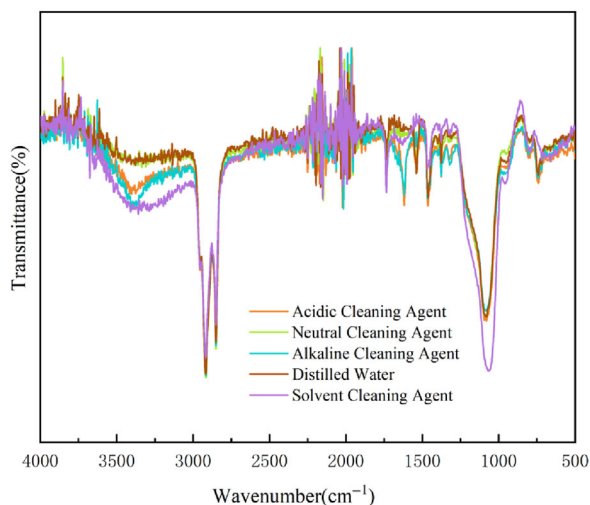
3.6.3 Infrared spectroscopy testing (FTIR). Infrared testing was conducted on the sample surfaces before and after immersion in the cleaning agent using attenuated total reflection. The results are shown in [Figure 17](#). From the infrared spectra, it can be seen that 750 cm^{-1} may be the absorption peak of the (CH_2) vibration, 1078 cm^{-1} may be the absorption peak of the C-O vibration, and 1458 cm^{-1} may be the absorption peak of Si (CH_3) 2 vibration peak absorption peak, 1609 cm^{-1} may be the C=C vibration peak absorption peak, indicating that the compound contains CH (3) and CH (2), 1745 cm^{-1} may be the conjugated C=O absorption peak, and 2913 cm^{-1} and 2849 cm^{-1} may be absorption peaks of saturated hydrocarbon C-H stretching vibrations. The peaks at 2913 cm^{-1} , 2849 cm^{-1} , 1745 cm^{-1} , 1609 cm^{-1} , 1458 cm^{-1} , 1078 cm^{-1} , and 750 cm^{-1} , indicating that the structural integrity of the windshield rubber samples remain unchanged after immersion in the cleaning agent. This further confirms that the diluted cleaning agent has negligible effects on the windshield rubber.

**Figure 17.** Infrared spectrum of windshield rubber after immersion in cleaning agent. **Source(s):** Author's own work

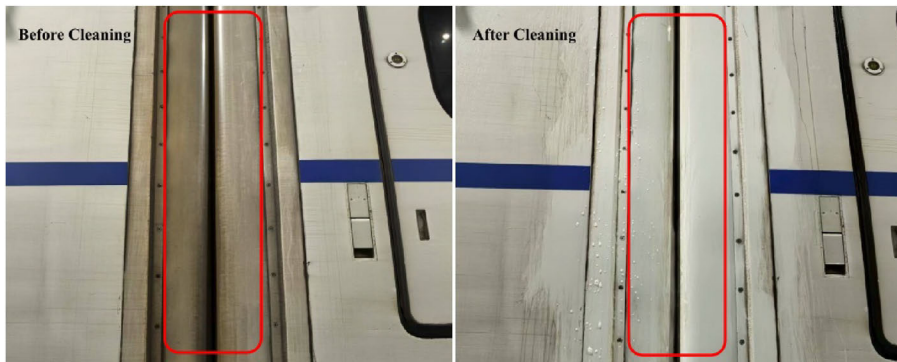
Figure 19. Windshield cleaning. **Source(s):** Author's own work

There are two kinds of specialized cleaning agents, including metal oxide stains: reddish-brown rust deposits formed by the oxidation of metal particles from rail friction or industrial dust; organic stains: accumulation of oil residues, atmospheric pollutants, and other micro-particles over time.

The above-mentioned yellow spot stains are washable. The specialized cleaning agents use a special raw material compounding process and contain small molecule chelating agents, which can chelate with divalent cationic metals (calcium, magnesium, iron, etc.) contained on the surface of the yellow spot. Although the chelated complexes adsorb onto the paint surface, their water solubility is enhanced under the action of cationic surfactants, and they no longer continue to grow and undergo lattice distortion, making it easy for scale to disperse and remove. The yellow spot removal rate is over 85%, which can effectively solve the problem of yellow spots on the outer surface of high-speed trains, as shown in [Figure 19](#).
