Wheel/rail-force-based maintenance interval extension of the C80 series wagon

Qi Xiao, Weidong Yu, Guangrong Tian and Fangxuan Li
*China Academy of Railway Sciences Corporation Limited,
Locomotive and Car Research Institute, Beijing, China*

Paper type Research paper

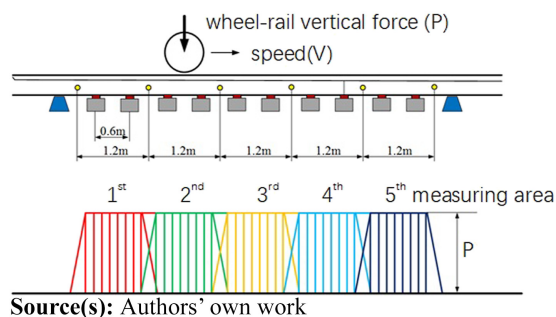
Figure 1. Schematic diagram of wheel-rail vertical force

TPDS achieved full-continuous wheel-rail force by 2D force plate and shear force sensor. The basic principle is to set several vertical pressure sensors under the rail track between two shear force sensors to form a wide detection area (Figures 1 and 2). The data collected from the two types of sensors can be calculated by modeling to obtain the wheel force of the wheel and rail at any position in the survey area. The “moving vertical force detection method” can substantially increase the length of the effective detection area without increasing the distance between sleepers and without deteriorating the smoothness of the track. Thanks to the extended continuous detection area, the average value and change trend of the wheel-rail force change process data can be measured for an extended period rather than an instantaneous value of the fluctuation process, which not only improves the detection accuracy but also dramatically increases the speed range applicable to the device.

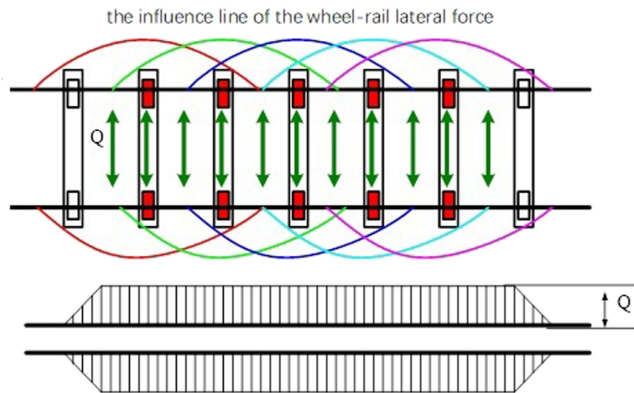
Figure 2.
Schematic diagram of
wheel-rail lateral force

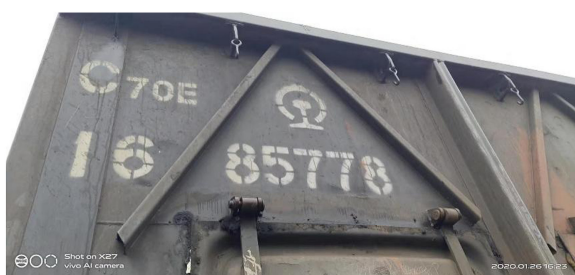
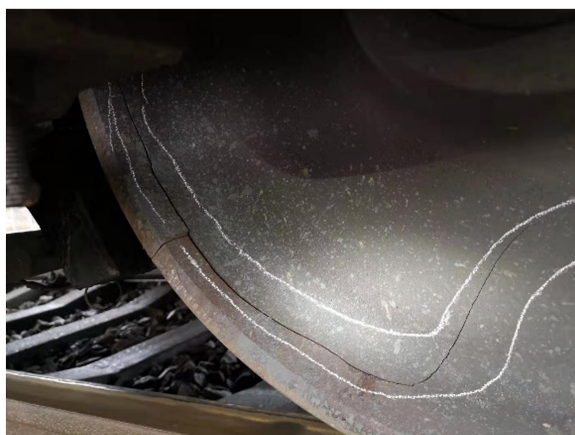
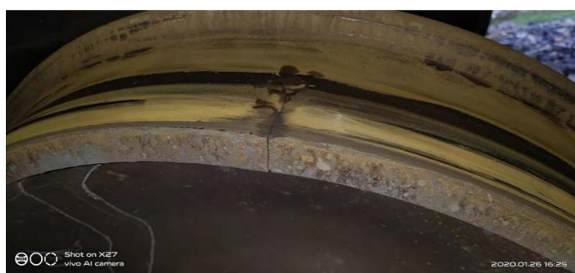
a circumferential crack of 468 mm

a rim crack of 28 mm

Figure 6.
Shattered rim of C70E
1685778

In January 2020, the wheels of a C70E wagon triggered two consecutive damage alarms when passing through the TPDS detection station (Table 1). After inspection by the operation workshop, it was found that the wheel had a circumferential crack of 468 mm, a radial crack of 310 mm and a rim crack of 28 mm (Figure 6). The car was immediately detained to prevent a possible wheel failure. Therefore, using TPDS, we can timely detect rim crack failures and prevent wheel collapse from causing train derailment.

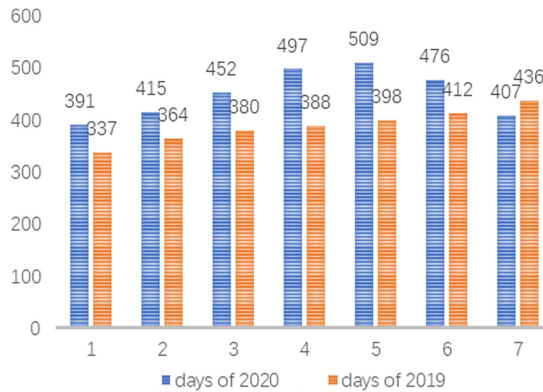
Figure 7.
C80 series wagon's
number of TPDS
hunting alarms

Another safety risk is hunting. Since 2020, the number of hunting detection alarms for freight cars has increased rapidly yearly (Figure 7). Significantly since 2020, this number has surged. Since May 2020, with the extension of the maintenance cycle and the increase in freight volume, more than 500 wagons are reported to be TPDS hunting alarms every month, including more than 39 C80 series wagons every month. In 2020, TPDS detected 468 vehicles/times of C80 series heavy haul wagons, reducing dynamic performance. The number of alerts has more than doubled compared to 2019.

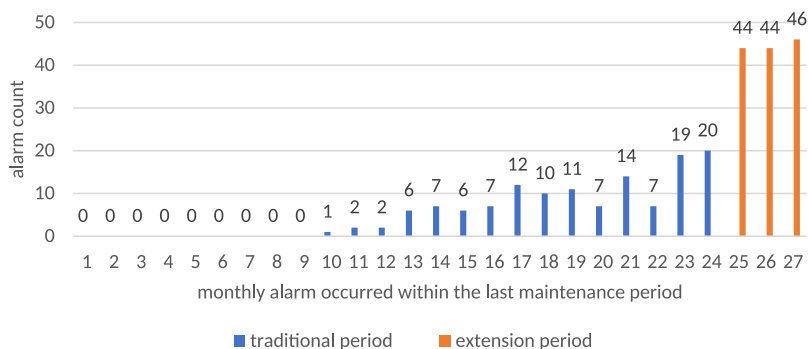
Figure 9. The monthly data of alarms wagons in the last maintenance period

Figure 9 counts the monthly alarms of these wagons in the last operating cycle. In the standard maintenance cycle of the latest maintenance period (24 months), the number of TPDS hunting alarms of the C80 series wagons also increased month by month. However, after entering the extension period, the number of monthly alarms nearly doubled and the highest in the 27th month, reaching 46 vehicles per month. Obviously, the extension of the repair system is the main reason for the increase in the number of TPDS hunting alarms in 2020.

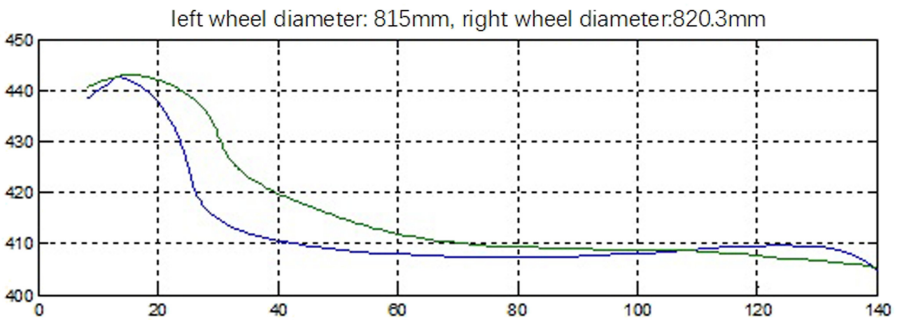
Figure 10.
The tread profiles of C80_{BH} 4390230 first axle

Figure 10 shows the measured comparison results of the tread profiles of the left and right wheels of the first axle of the C80_{BH}4390230. It can be seen that the tread wear of the left and right wheels of the car is very different.
