Analysis of corrugation evolution characteristics based on scale-down tests – contact stick-slip perspective

Abstract

Paper type Research paper

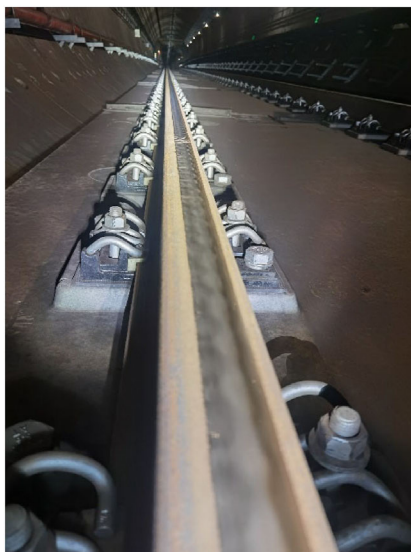
Figure 1. Rail corrugation on the straight line. Source: Authors' own work

Corrugation is a periodic wave-like wear appearing on the rail surface, as shown in [Figure 1](#), commonly found on urban rail transit lines. Affected by line operating conditions, corrugation forms vary in the performance, and corrugation for a long time has not been effectively managed. Unlike the even wear, corrugation destroys the continuity of the contact surface, thus easily inducing abnormal vibration and high-frequency noise in the wheel-rail system and may lead to fatigue failure of related components, so the control of corrugation is crucial to ensure the normal operation of the rail transit system ([Ling et al., 2017](#); [Wei, Sun, Zeng, & Qu, 2022](#); [Cui et al., 2023](#)). Typically, most corrugation occurs on small curve tracks with the radius below 350 m, and the occurrence probability of corrugation on these types of tracks is close to 100% ([Mei & Chen, 2023](#)). In addition, in the straight track, corrugation also has the possibility to occur and is generally presented as short-pitch corrugation, which is mainly associated with the specific track structures ([Zhang, Liu, Liu, & Wu, 2014](#); [Liu, Zhang, Liu, &](#)

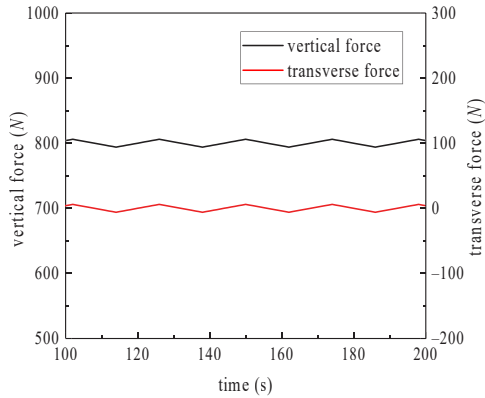
As can be seen from Figure 3, when the rail wheel is running, the vertical force varies in the range of 794–806 N, and the transverse force varies in the range of -5–5 N, with fluctuations below 15 N. Compared to the vertical load of 800 N, the fluctuation amplitudes of the above forces are relatively small (<2%), and therefore the test device is relatively stable.

Figure 3. Variation curve of vertical/transverse force. Source: Authors' own work

The stability of the test device determines the reliability of the test results, therefore, it is necessary to calibrate the stability of the test device. By modulating the rotating disc of the angle adjustment device, the angle of attack between the wheel and the rail wheel is set to 0°. The vertical load is set to 800 N, and the running frequency of the rail wheel is set to 160 r/min. The test device is then activated and the vertical and transverse force indications are recorded. The above test procedure is repeated three times with a duration of 10 min each time, that is the rail wheel is running for a total of 1,600 r in a single run. By averaging the data from three tests, the vertical and transverse force variation curves can be obtained, as shown in Figure 3.

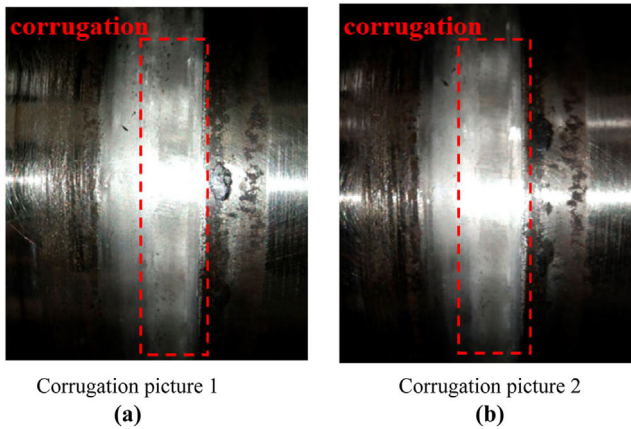
Figure 8. Test results for condition 4. Source: Authors' own work

As can be seen in [Figures 7 and 8](#), at the angles of attack of 1.5° and 2° , the surface of the rail wheel after the completion of the test also shows the phenomenon of corrugation, but the corrugation wavelength is longer than that shown in [Figures 5 and 6](#), about 11 mm (corresponding to the corrugation passing frequency of about 76.16 Hz), as shown in [Figure 12](#). This indicates that the corrugation formation mechanism in [Figures 7 and 8](#) is

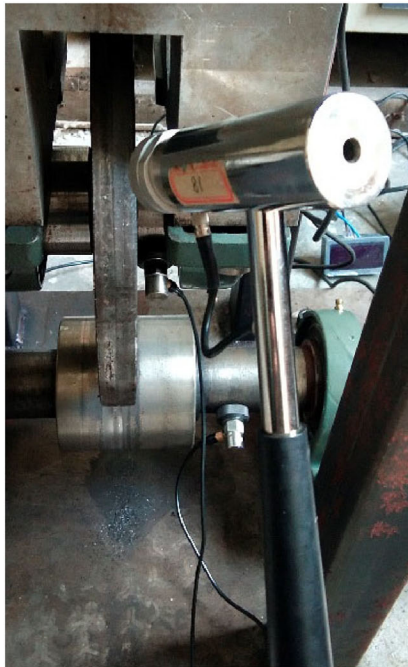
Figure 10. The percussion hammer. Source: Authors' own work

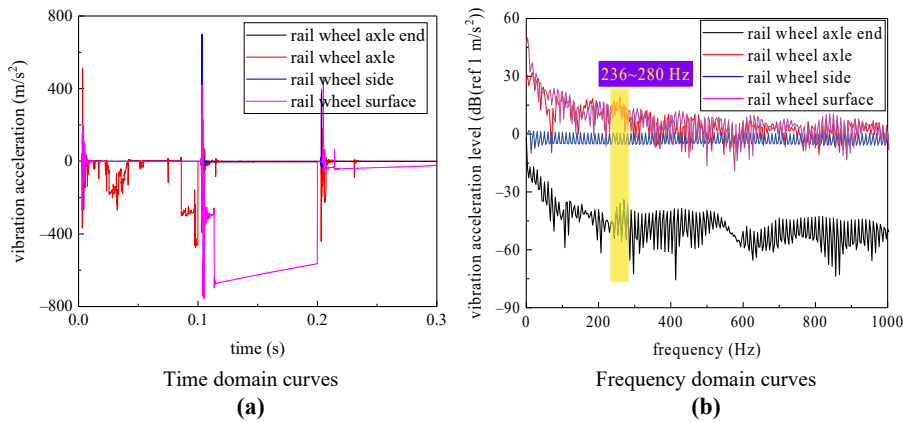
wheel, thus not easy to cause obvious changes in the vibration of the rail wheel side.). The results of the hammering test indicate that the inherent vibration characteristics of the test device in the range of 236–280 Hz may be the main cause of corrugation with a wavelength of 3–4 mm on the rail wheel surface.

Figure 11. Hammering test results. Source: Authors' own work

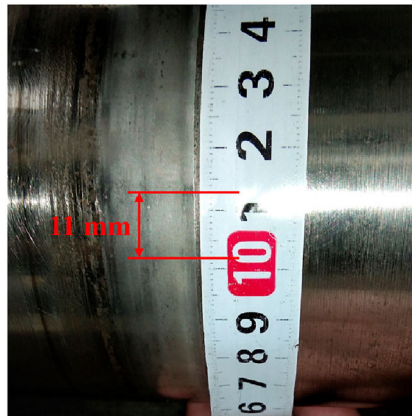
Figure 12. Corrugation wavelength for condition 4. Source: Authors' own work

different from that in Figures 5 and 6. According to Figure 4, it can be seen that the contact angles of attack of 1.5° and 2° in conditions 3 and 4 have reached and exceeded the critical value, and at this time, the contact interface is very prone to generate stick-slip vibration, which in turn promotes the formation of corrugation. Because the corrugation form in conditions 3 and 4 is transformed relative to the form in conditions 1 and 2, and the transverse creepage has reached and exceeded the saturation value, thus the cause of the surface corrugation of the rail wheel in conditions 3 and 4 is mainly related to the stick-slip vibration caused by the saturation of the contact creepage.
