2023年积石山地震重要公共建筑吊顶 震害调查分析

Investigation of seismic damage to ceilings of public buildings during the 2023 Jishishan earthquake

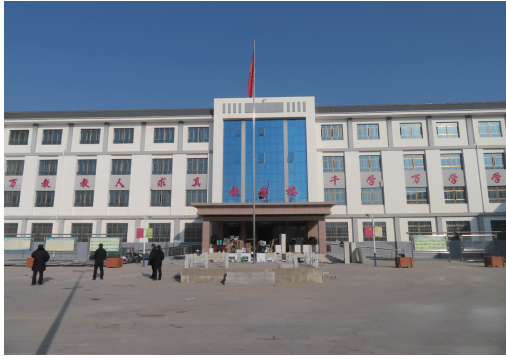
图2 大河家中学教学楼

大河家中学位于积石山县大河家镇,距离震中约17 km,其教学楼为4层框架结构,于2020年竣工,如图2所示。建筑外观没有明显破坏,但内部吊顶破坏比较严重。以往震害调查中,公共建筑多数采用矿棉板吊顶^[2],而大河家中学教学楼大量采用铝扣板吊顶,如图3所示,且作为逃生通道的走廊上方多数为此类吊顶。铝扣板质地轻便耐用,被广泛运用于家装吊顶中。大河家中学铝扣板吊顶的次龙骨采用三角龙骨,铝扣板采用托卡固定方式,即铝扣板四边均匀分布略凸起的凸棱,安装时将其中对称两边轻压,卡入三角龙骨缝隙内再压紧,如图4所示。这一构造方式对龙骨骨架的平整度要求较高。

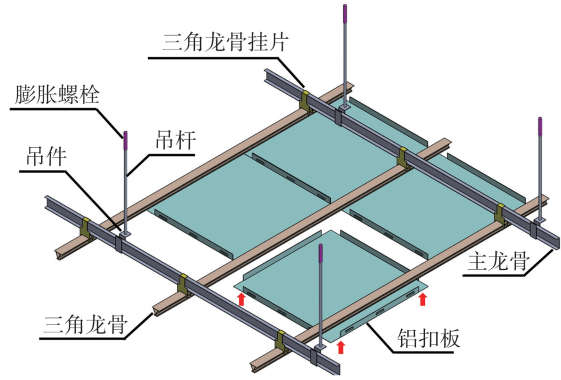
图3 铝扣板吊顶布置图

铝扣板吊顶震害与此前常见的矿棉板吊顶震害的共同点是边角破坏比较严重。铝扣板吊顶震害的特殊性是:①由图3和图4可见,三角龙骨同一位置同时卡入2块铝扣板,2块板的卡入边在地震中往往同时脱离三角龙骨,呈对称破坏状态。②不同于矿棉板,铝扣板为金属吊顶板,具有锋利的边角,坠板致伤的可能性较大。幸运的是此次地震发生在深夜,教学楼内没有人员需要疏散,因此并未因坠板造成人员伤亡。③卡入式连接对龙骨网络的抗震性能要求更高,需要始终保持较高的平整度;且卡入连接仅为承担板重而设置,不足以抵抗地震荷载,地震中大量的连接失效足以证明这点。大河家中学吊顶震害和铝扣板吊顶典型震害如图5和图6所示。
