积石山 6.2 级地震桥梁典型震害特征

摘要: 调查了 306 省道、310 国道以及川亭公路上位于地震烈度 8 度和 7 度区的桥梁。GS.N0028 台站记录到的大河家镇加速度峰值超过 900 cm/s², 远超当地罕遇地震设防标准, 但从调查的结果看, 本次地震中, 8 度区的桥梁震害主要以轻微破坏为主, 包括挡块破坏、主梁侧移和支座滑移, 除了川亭公路上发现一桥梁的桥墩出现剪切裂缝外, 其他桥梁未发现主体结构发生破坏。7 度区的桥梁基本完好, 橡胶支座中橡胶有变形无法恢复以及主梁位移导致挡块间距发生变化, 但都不影响功能。混凝土挡块作为主梁防侧移装置, 震害虽然表明其有效性, 但缺乏快速恢复的特性, 同时设置缓冲橡胶垫的挡块仍然发生了较严重的破坏, 因此, 以后需要进一步加强挡块的缓冲装置和考虑可快速恢复性能的研究。

Typical seismic damage characteristics of bridges in the M_s 6.2 Jishishan earthquake

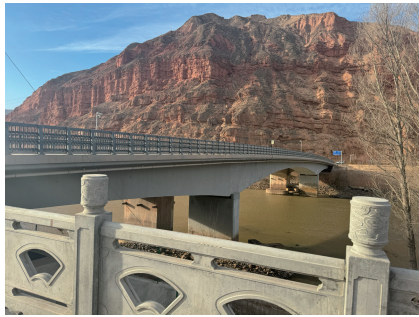
图1 大河家黄河大桥(新桥)

大河家黄河大桥新桥为 3 跨 1 联(45 m+90 m+45 m)的预应力混凝土连续梁桥,桥梁全长 185.5 m,行车道净宽 9.0 m,如图 1 所示。大河家黄河大桥新桥位于 8 度区,主体桥墩、梁未见裂缝,主要的震害包括在桥

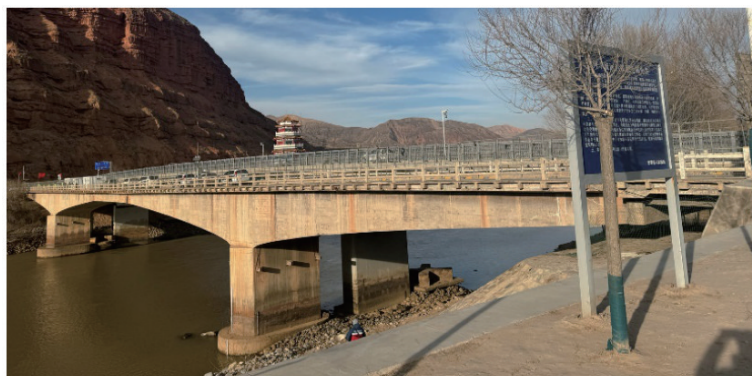
图 11 大河家黄河大桥旧桥

在本次地震中,大河家黄河大桥旧桥位于 8 度区,桥梁主体桥墩、梁未发现明显裂缝,如图 11 所示。主要震害包括跨中“挂梁”挡块发生破坏,如图 12 所示。跨中梁体横向侧移及纵向碰撞如图 13 和图 14 所示。从震害可以看到中部增加的简支梁在地震中易因碰撞发生破坏。

大河家黄河大桥旧桥中间增加的挂梁^[7],由于无墩柱支撑,其极易在地震中造成碰撞、落梁等破坏,需要增加可靠措施进行加固^[8-11]。

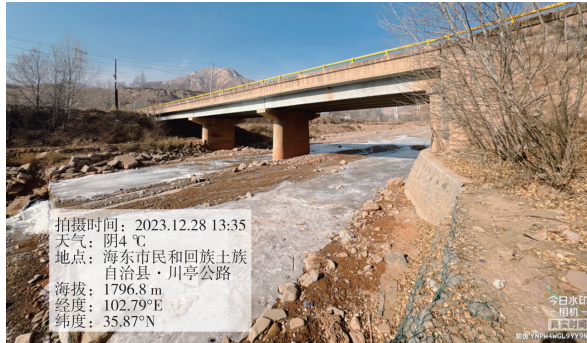
图 20 川亭公路通往官亭镇的公路桥梁

川亭公路通往官亭镇的公路桥梁为一个 3 跨 T 梁简支梁桥如图 20 所示, 桥墩为重力式桥墩, 未发现支座, 中间墩底部有冲刷痕迹。该桥梁位于川亭公路通往官亭镇公路上, 8 度区, 中间跨一桥墩发生严重剪切裂缝, 最长缝长 140 cm 左右, 如图 21 和图 22 所示, 图 21 和 22 中的横向裂缝判断应该是施工缝^[12-14]。该公路桥梁被鉴定为危桥, 整体属于中等破坏^[15]。

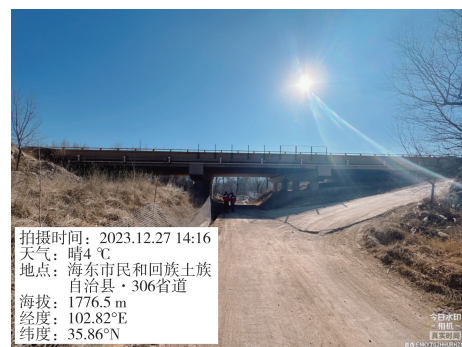
图 23 306 省道 K8 段公路桥梁

306 省道 K8 段的公路桥梁为双向上下行线的 2 座桥, 均为 3 跨简支梁桥如图 23 所示, 支座为板式橡胶支座。桥梁的桥墩、梁未发现破坏。在桥梁的两端、中间的挡块均由于主梁横向位移导致碰撞而破坏, 其中两端较重, 而中间较轻如图 24 和图 25 所示。两端和中间支座均发生了不同程度的滑移, 最大达到约 10 cm, 如图 26 所示。梁端与桥台发生碰撞及错动如图 27 所示。此桥梁端部挡块设置了缓冲橡胶, 仍然发生了严重的破坏, 中部未设缓存橡胶, 挡块的破坏说明了挡块在抵抗主梁横向移动的有效性^[16-18], 但无法做到快速恢复。设计足够有效且能快速恢复的挡块是一个值得考虑的问题^[19-20], 而且需要对挡块的缓冲装置性能进行进一步的研究。
