# Seismic damage characteristics and resilience design of cross-fault tunnels: New insights from the Daliang Tunnel in the 2022 Menyuan $M_W$ 6.6 Earthquake

An earthquake with a magnitude of 6.6 ( $M_W$ ) occurred in Menyuan County, Qinghai Province, China, on January 8th, 2022. The Daliang Tunnel, which traverses the seismogenic fault, was severely damaged during this seismic event. The seismic damage investigation of the tunnel is introduced, and the damage characteristics along the tunnel are also presented. It is found that the damage severity of the tunnel is highly correlated with the distance to the fault. Damage modes for different tunnel zones (cross-fault zone, portal zone, and ordinary zone far from the fault and the portal) are quite distinct. Based on the understanding of seismic damage to the Daliang Tunnel in 2022 Menyuan Earthquake, as well as other damaged tunnels during the 2008 Wenchuan Earthquake, the critical influence factors for damage to cross-fault tunnels are discussed. From the seismic investigation, coupling effects of strong ground motions and fault dislocations are highlighted, which pose significant risks to cross-fault tunnels and should be consider

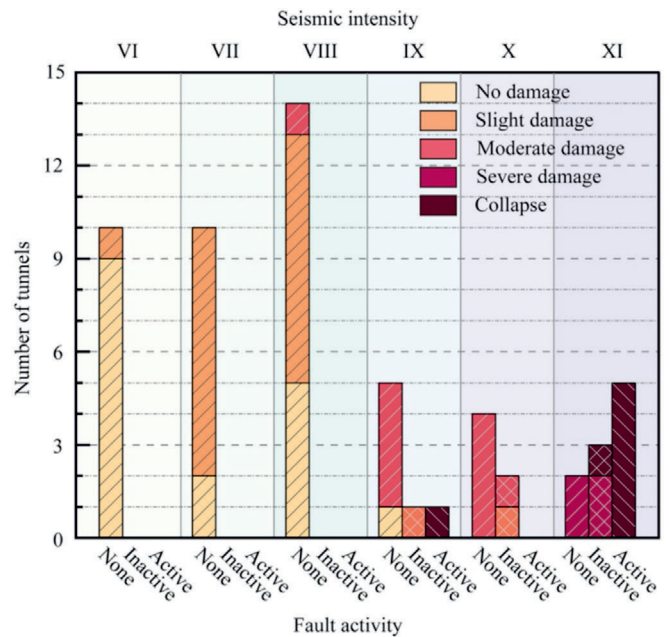
Fig. 14. Effects of the earthquake intensity and fault activity on tunnel damage level.

located in the VII and VIII-degree seismic intensity regions, but not crossing faults, experienced minor or no damage. However, tunnels situated in the regions with seismic intensity as high as X and XI degrees suffered more severe damage, even if there is no fault crossing, tunnel collapse would be expected. This indicates that it is important to provide the seismic intensity accurately for the design of tunnel

It can also be observed from Fig. 14 that the fault activity would significantly exacerbate the seismic damage to tunnels. More specifically, tunnels located in areas with the same earthquake intensity but crossing faults consistently exhibited more severe damage than tunnels that did not cross faults. Besides, all the investigated tunnels crossing active faults in the XI-degree intensity zone have collapsed, which indicates that the coupling effect of strong ground motion and fault dislocation is prominent and should be considered in the seismic design for tunnel structures crossing the active fault.

Figure 14 indicates that 35 of the 57 investigated tunnels were located in VIII-degree intensity regions or higher, accounting for over 60% of the total. This suggests that the actual seismic loads during these two earthquakes exceeded the estimated design loads. This reveals the gap in current design methods, especially for sites with active faults, where seismic loads may be underestimated. Thus, understanding the coupling mechanism between ground motion and fault dislocation, as well as accurately estimating seismic loads, is essential for seismic design of cross-fault tunnels. The characterization of the geometric sizes and seismic histories of large fault zones can be very useful for estimating the possible maximum magnitude of earthquakes as well as predicting their recurrence behavior, which would be important for the assessment of caprock (or host rock) integrity over the long term.

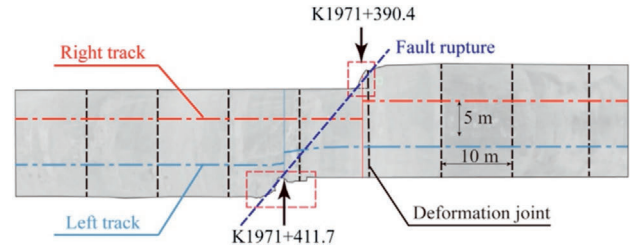
Fig. 16. Schematic diagram of the deformation pattern of the cross-fault zone along the Daliang Tunnel.

Figure 16 shows the detailed arrangement of deformation joints along the cross-fault section of the Daliang Tunnel. It can be seen from the figure that the spacing for each adjacent deformation joint was set as 10 m. The intersection angle between the fault rupture and the tunnel axis was determined to be approximately 50°, based on the strike of the surface rupture. Because of this oblique intersection, the fault rupture may intersect on both sides of the tunnel near the joints, resulting in the lining dislocations observed around the deformation joints.

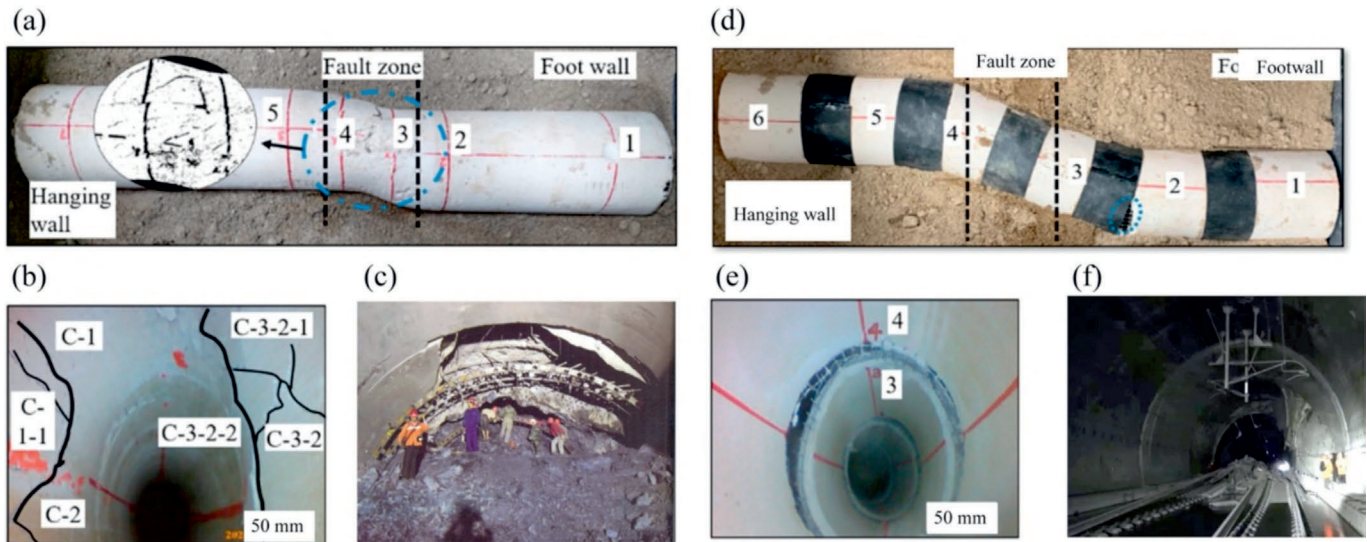
shown in the figure are consistent with the damage observed in the Longxi Tunnel and the Daliang Tunnel, in which the tunnel with deformation joints exhibited less damage but greater deformation compared to the tunnel without joints. The observed structural damage and deformation were mainly concentrated around the flexible joints, suggesting that the deformation joints along the cross-fault section of the Daliang Tunnel play a protective role in mitigating widespread structural damage, while simultaneously leading to pronounced localized lining deformation near the fault rupture plane. This can be taken as an indicator that the deformation joints have dual characters: on one hand, they can effectively protect the main tunnel structure by adapting to the dislocation distribution along the cross-fault section of the tunnel during a seismic event; on the other hand, an added local deformation may be expected around the deformation joints, and furthermore the water proof capability of the joints should also be paid more attention in practical design.

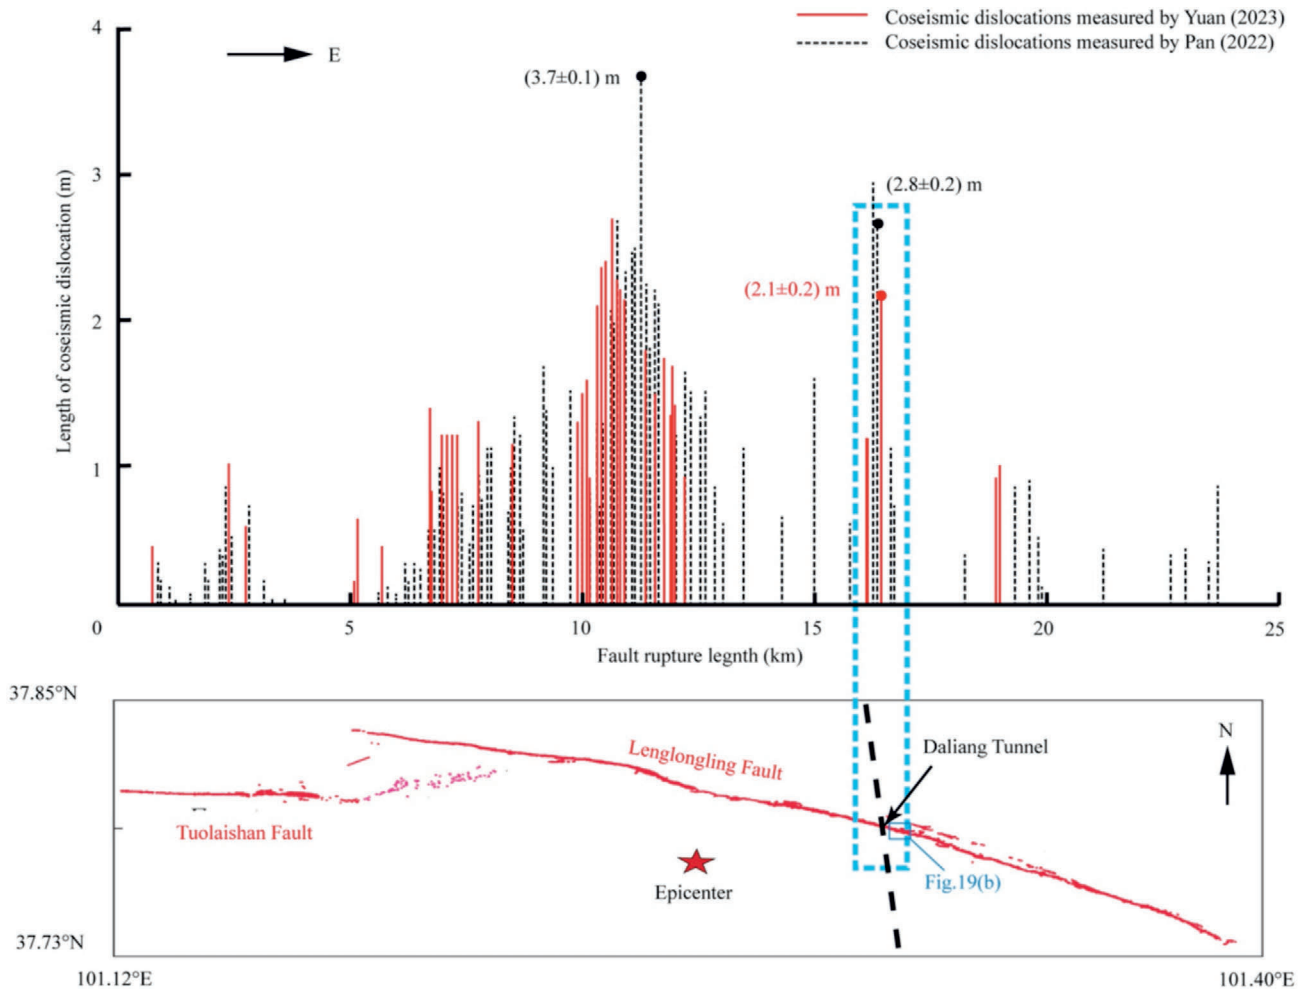
Fig. 18. Horizontal coseismic dislocations along the surface rupture zone of the 2022 Menyuan Earthquake. (Modified from Pan et al. (2022) and Yuan et al. (2023))

Figure 18 illustrates the distribution of coseismic surface rupture dislocation along the LLL Fault, which follows an approximate normal distribution consistent with the theoretical solution proposed by Okada (1985). The largest dis-

Combined with the field investigation near the Daliang Tunnel, it can be concluded that the slope instability may be one of the potential causes for this localized amplification of fault rupture dislocation. Figure 19 shows several landslides distributed along the main surface rupture zone of the earthquake, one of which is located directly on the slope above the Daliang Tunnel. Note that the near-surface soils in this area are loose and unstable, especially near the northern portal of the Daliang Tunnel, with a slope gradient of more than 30%, which can be regarded as a steep slope. As a result, landslides and slope instability are more likely to occur along these major surface ruptures.
