# 发动机焊接结构全场应变和温度同步测试研究

**摘要** 为了研究大载荷循环作用下焊接结构的疲劳强度,采用数字图像相关(digital image correlation,简称DIC)和红外热成像(infrared thermography,简称IR)同步耦合测试方法,同时获取结构表面的全场应变和温度信息,解释了结构损伤的演变过程。首先,通过45#钢试样的拉伸试验,获得了45#钢拉伸过程中试样表面的温度和应变变化规律;其次,损伤过程各阶段中温度特征与材料载荷时间曲线吻合程度较好,反映了45#钢损伤状态的不同历程;最后,开展了发动机GH4061焊接结构超低周循环疲劳试验,捕捉了焊接结构在循环载荷作用下裂纹的萌生、发展和断裂的全过程,并进行了全场应变和温度的同步测试分析。试验结果验证了该方法在焊接结构疲劳损伤监测中的可行性与有效性。

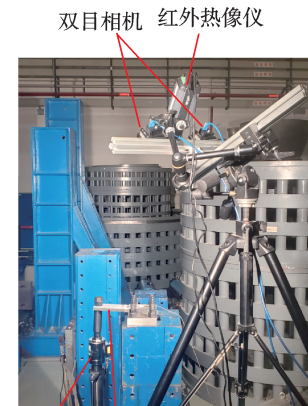
图7 DIC和IR测试现场

Fig.7 Testing site with DIC and IR

验。试样由2块GH4061板材焊接而成,其尺寸如图5所示。试验加载采用SAWEB 10 t作动器施加垂直方向的位移控制,循环位移为±16 mm,对应的力载荷约为35 kN。固支支撑使用了4个螺栓,焊接件安装情况如图6所示。图7为DIC和IR测试现场,所使用的可见光相机和红外热像仪的型号与拉伸试验时所用的相同,作动筒施加的力频率为0.25 Hz。为了捕捉一个循环周期内完整的表面应变和温度的变化情况,相机的帧速率被设定为5 fps,即一个加载周期内采集20张图像。试样表面制作有黑白斑点图案,DIC数据分析使用归一化平方差和作为相关匹配准则,子集大小为37×37像素,步长为9,应变窗口为15×15个位移点,每个像素大小约为354.0 μm。

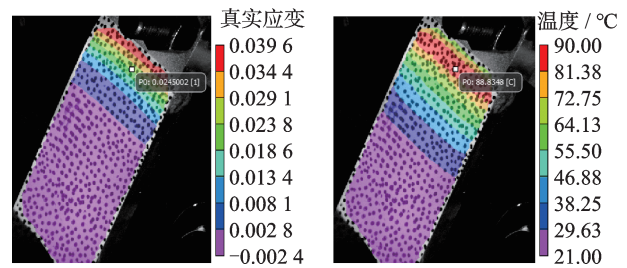
图 10 C 时刻试样表面的应变和温度云图

Fig.10 Strain and temperature contour maps of the specimen surface at time C

在整个循环加载至结构断裂的过程中,  $P_0$  点真实应变和温度随循环次数的变化规律如图 8 所示。从加载一开始, 试样就出现较大的塑性应变, 表面温度也迅速上升。温度曲线的波动主要是由于试验时焊接件发生了较大位移, 其相对于红外摄像仪的方位发生变化, 导致实际发射率改变, 而测量中发射率固定为 0.9, 未考虑方位改变的影响。在前 12 个循环载荷阶段, 温度上升速度较快, 之后应变峰值保持稳定, 温度持续均匀升高。到第 38 个循环载荷 (A 时刻) 时, 通过检查试样图像发现, 此时试样表面出现了裂纹, 不同时刻的裂纹扩展图像如图 9 所示。到第 97 个循环载荷 (C 时刻) 时, 表面裂纹尺寸扩大到 2.764 mm。在之后的循环载荷作用下, 裂纹快速扩展, 温度上升的斜率增大, 直到第 115 个循环 (E 时刻), 裂纹已贯穿整个表面, 至第 124 个循环 (F 时刻), 结构发生断裂。在此全过程中, 试样表面温度从初始时的 21.1 °C 上升到最高的 89.8 °C (D 时刻), 最大温升达 68.7 °C。从第 97 个循环开始, 裂纹迅速扩展, 这在应变和温度上都有体现, 即伴随着应变增加和温度上升的斜率增加。然而, 实际中全场应变的测试分析相对复杂, 而温度可以通过红外热像仪很方便地进行全场实时测量, 因此未来红外温度测量有望用于识别发动机故障发生前的结构性能退化。图 10 为 C 时刻试样表面的应变和温度云图。可以看出, 试样根部应变最大, 而最大温度出现位置与裂纹位置一致。
